SERVICE BULLETIN

NEW RUBBER GASKET

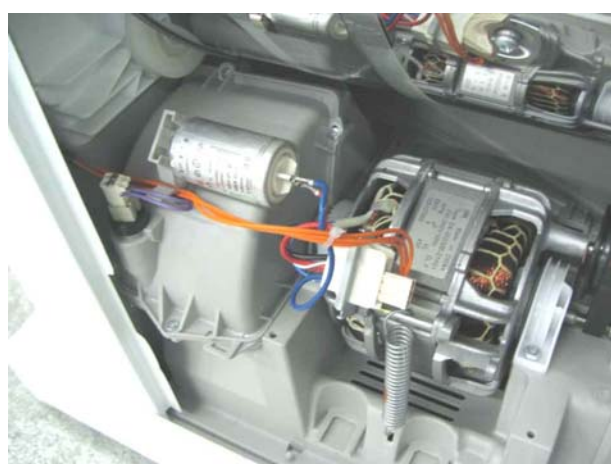
Before modification

It has been discovered in the laboratories of the Siewierz factory (Poland) that in some dryers, after working hours in extreme conditions, on the motor shaft, which activates the front fan (hot air circulation) there was excessive humidity and cloth fibres came out from the front scroll. To avoid any possible malfunctioning a new basket has been introduced between the motor shaft and the front scroll cover.
