SERVICE BULLETIN

Reg. No.: 450 / 97

RM4260 / RM4270 / RM4290 / RM4360 / RM4400 / RM5270 / RM5405 and ignition-variants

INSUFFICIENT COOLING PERFORMANCE INSIDE THE FREEZER COMPARTMENT

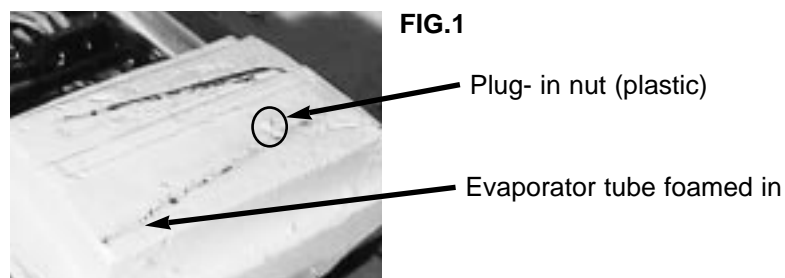
During production of some caravan refrigerators with wide freezer compartment, the evaporator tube has been foamed in (FIG.1). Consequently, there is no contact between the evaporator tube and the freezer compartment, causing low cooling performance.

- 1.) Remove the cooling unit.
- 2.) Check if the tube is over foamed (see FIG.1).
- 3.) If this is the case, change the cooling unit.
- 4.) Rework the removed cooling unit in the service-station and use it for the next service.
