**Service Bulletin**

**Ref No: DW02011**

**Subject: Leakage in base tray / activation of float switch**

**Brand: ZANUSSI**

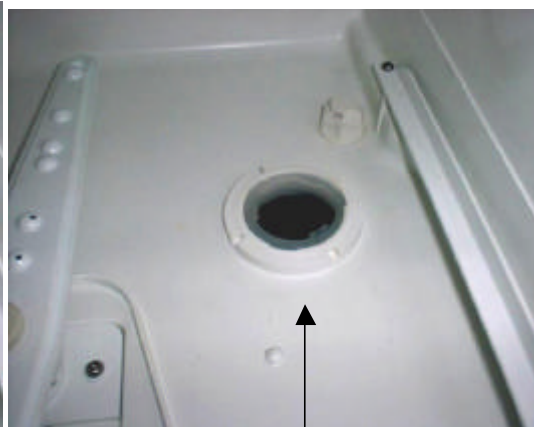
Lock nut

This could be caused the lock nut under the salt cap being very loose.

It is very important on any service calls made to the compact dishwasher that the locknut is checked to ensure it is fully tightened. It should not be possible to unscrew by hand.

If the lock nut requires to be tightened, care should be taken not to fracture the nut or the plastic base.
