### Dishwashers with Turbo condensation dry cycle

**Problem:** Dew-formation on the left top part of the door and below the counter or at the neighbouring base unit.

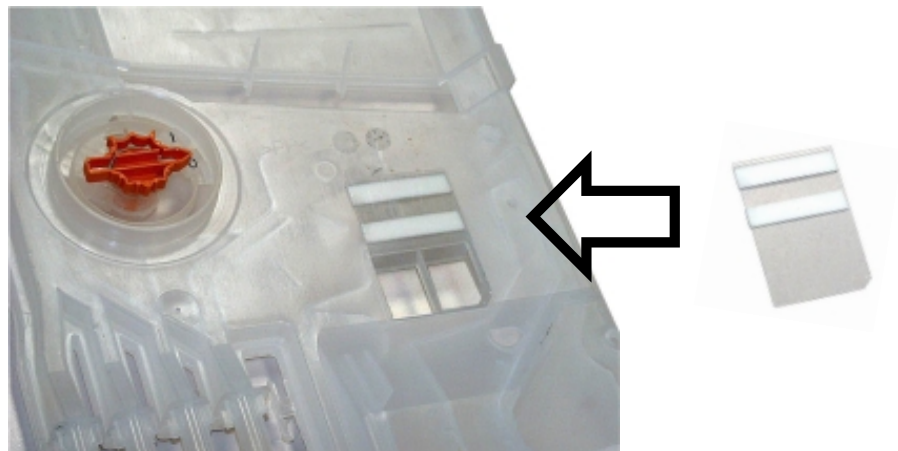
**Fig. 1**

**Cause:** The dry ventilator is responsible for creating inside the condensation unit of the regeneration dosing unit a slight overpressure above atmospheric. When leakages occur in this area, hot and moist air will penetrate from the rinsing container and condensate at the kitchen units, as described above.

**Remedy:** Leakages can be effectively reduced by a foil, PN 111 860 900/5, and with commercial silicone for sanitary purposes.

- Completely dismantle the left sidewall, regeneration dosing unit and fan.
- Stick foil, PN 111 860 900/5, to the rinsing container ventilation, as shown in the figure. The foil will not completely seal the rinsing container ventilation, but will flap open in case of overpressure like a ventilation damper.
