SERVICE BULLETIN

RM 6XX0, RM 6XX1, RM 7XX0

Oversized leak test pressure

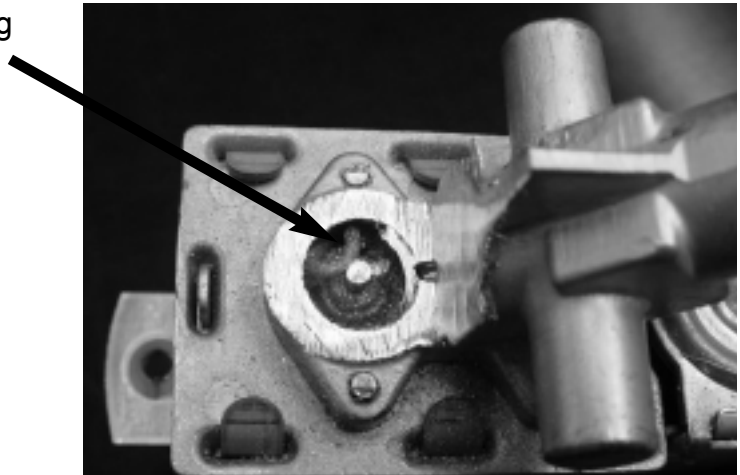
A very small amount of fridges type RM 6xx0 and RM 6xx1 were found on the market showing up a leak around the control device.

Tests proved without any doubt that those leaks had come up due to an improper increase of air pressure to the control device during leak test operation at the OEM or the dealer's place.

The diaphragms of the above mentioned control devices were moved out of their sealing position due to an inappropriate increase of pressure.

This leads to an exterior leak. It is possible that this leak might not be detected while carrying out the leak test at the gas installation in the vehicle, as the tests according to the installation standard are only carried out up to the magnet insert of the flame failure safety device (FFD).

This picture shows an improper sealing diaphragm on the gas inlet.

To avoid problems / leakages like described above, secure

that leak tests carried out with no more than 150 mbar
