### SERVICE BULLETIN

RM 7211LSC, RM 7271, RM 7291, RM 7361, RM 7365, RM 7401, RM 7405, RM 7601,  
RM 7605, RM 7651, RM 7655

### Ignition Problems RM 7XX1 and RM 7XX5!

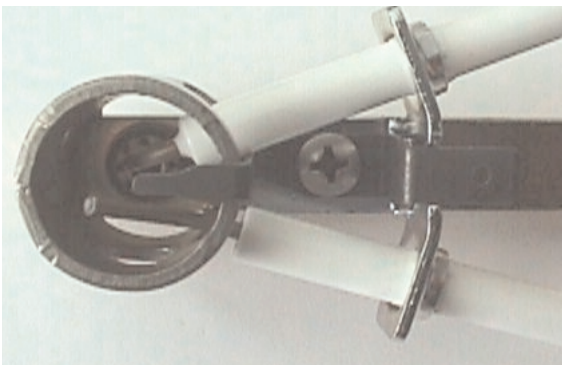
Due to production tolerances it might happen that the space between the ignition plug and the bottom of the burner housing is too small. Thus, a correct ignition is not always possible, as the spark might jump over to the burner housing.

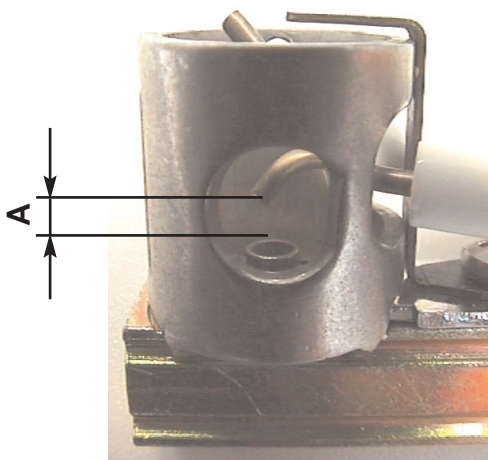
Several deflagrations can be recognized, which after 20 seconds lead to a malfunction (yellow LED on the operating panel lights up). If this malfunction occurs, the holder can be bended to the back with the help of a pair of tongs. The space (A) should be between 7-9 mm.
