Service-Bulletin

Washing machines

599 521 210 EN

Discoloration at the rubber bellow

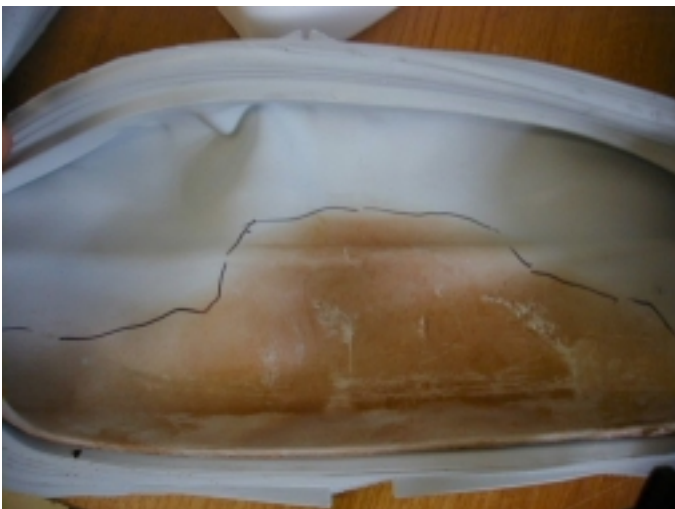
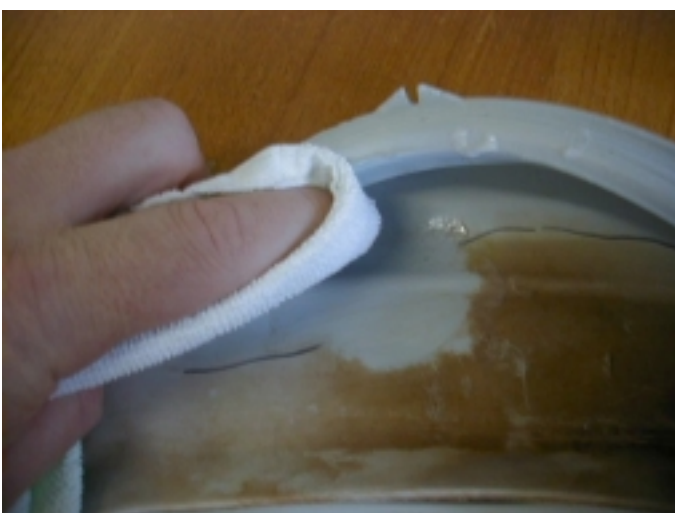
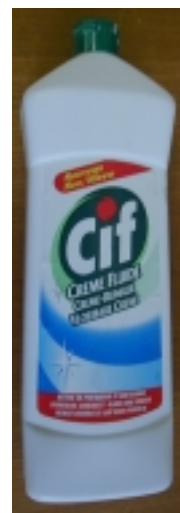
Cause: Depending on water quality and kind of water lines to the washing machine it is possible that rust-brown deposits may arise ahead and rear at the rubber bellow. According to a material analysis by the Henkel company, this discoloration contains high parts of iron as well as copper and manganese.

Measure: Depending on fouling factor it is possible to clean the brown discoloration at the rubber bellow with a commercial household detergent. When a cleaning is no more possible, the rubber bellow can only be replaced.
