SERVICE BULLETIN

RM 7211/71/75/91/95, RM 7361/65/71/91/95, RM 7401/05, RM 7501/41/45/51/55, RM 7601/05/51/55, RM 7801/05/51/55

Additional Ground connection for MES and AES III

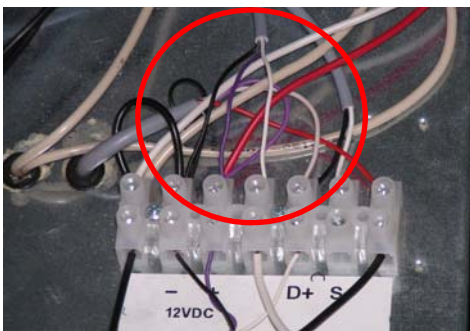
Wiring of connection cable, factory-made

An inadequate ground connection in the leisure vehicle can cause a high current flow via the electronics (contact X105) of the fridge to the grounding at the gas line.
