Service-Bulletin

Washing machines

599 530 226 EN

Toploader Leaky at the rear panel

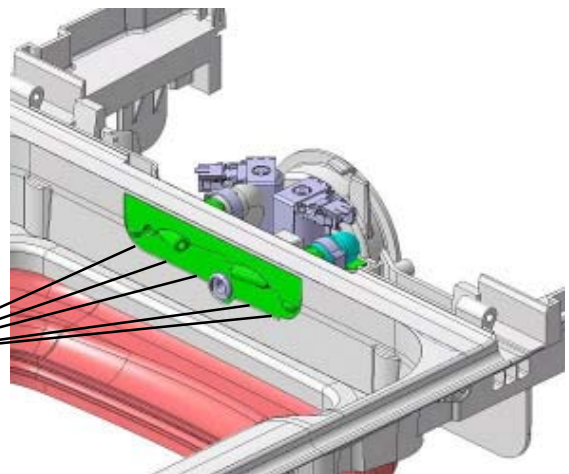
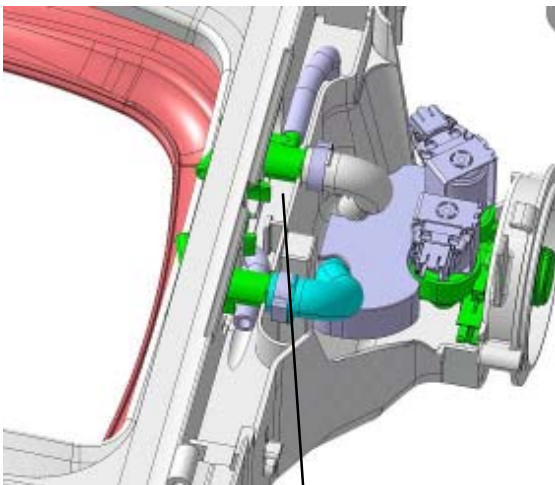
Cause: Affected are only appliances with series no. 723 which have a water distributor from the tool no. 2.
Water is pressed between the upper part and the water distributor in the area of the inlet valve during the filling process of the softener (only when both inlet nozzles are selected).

Leaky between upper part
and water distributor

Measure: Remove the stud at the water distributor. Thereby the water can flow back again into the tub.

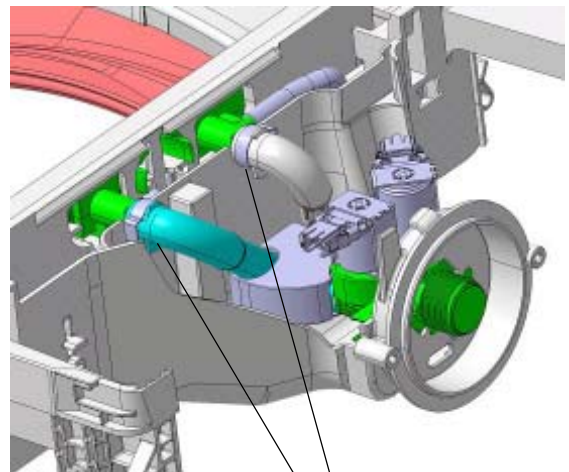
Water level increases

Water runs over between hose and upper part
