### FLUCTUATION OF TEMPERATURE ON NOFROST

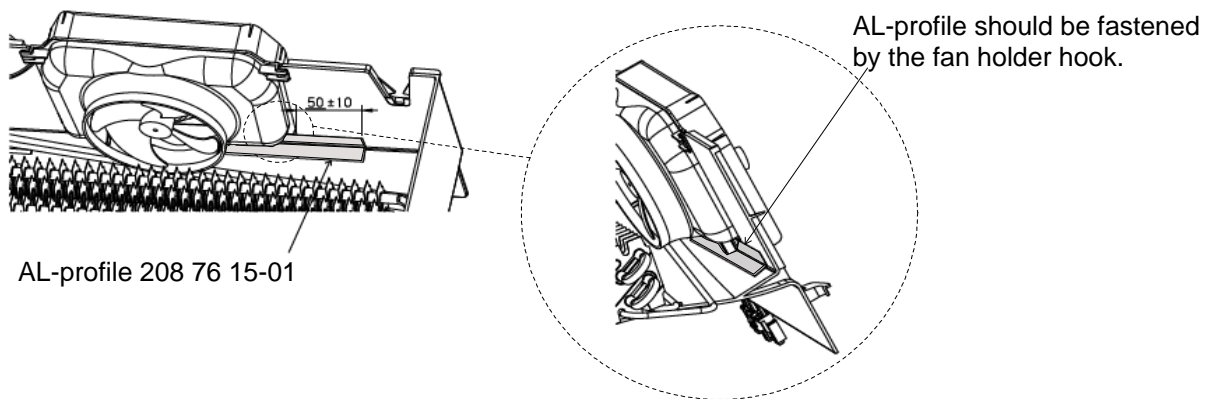
If the freezer has fluctuation of temperature, the reason is that the fan may jam. The service action for appliances up to serial no 825 is to change the fan cpl. The metal plate in the nofrost module should also be pressed down against the bottom, by using AL-profile 208 76 15-01, (se picture) to prevent ice accumulation, valid for appliances up to serial no 837.

Fan cpl according to the spare parts list and the AL-profile 208 76 15-01 can be ordered from Distriparts.
