**EXCESSIVE ICE BUILD-UP AND EXCESSIVE TEMPERATURES IN
APPLIANCES WITH BATTERY EVAPORATORS**

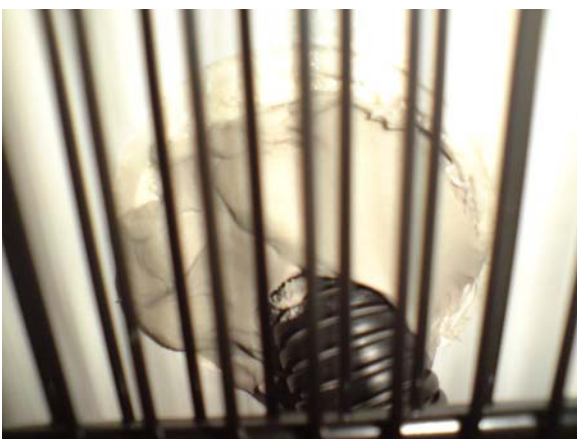
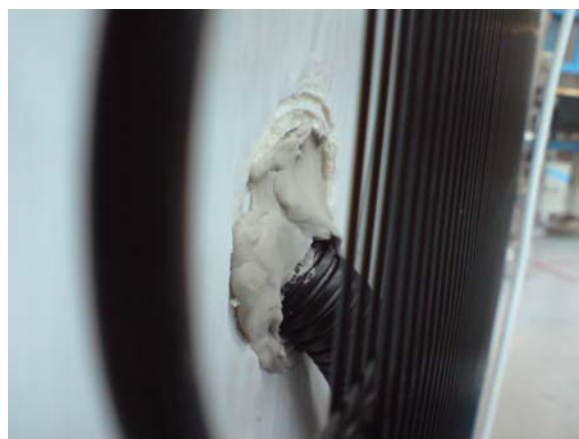
1. Insufficient seal on the defrost water drainage duct
2. Insufficient insulation in the rear section of the battery evaporator (only applicable to models with serial numbers up to 750xxxxxx)
3. Water discharge valve defective (only applicable to models with serial numbers up to 910xxxxxx)

1. Carefully seal the water drainage duct using sealant (part number 960016954) as shown in the figure below.

N.B. It is necessary to move the condenser sideways in order to seal the duct.
