**TEMPERATURE FLUCTUATIONS IN TOTAL NO-FROST MODELS**

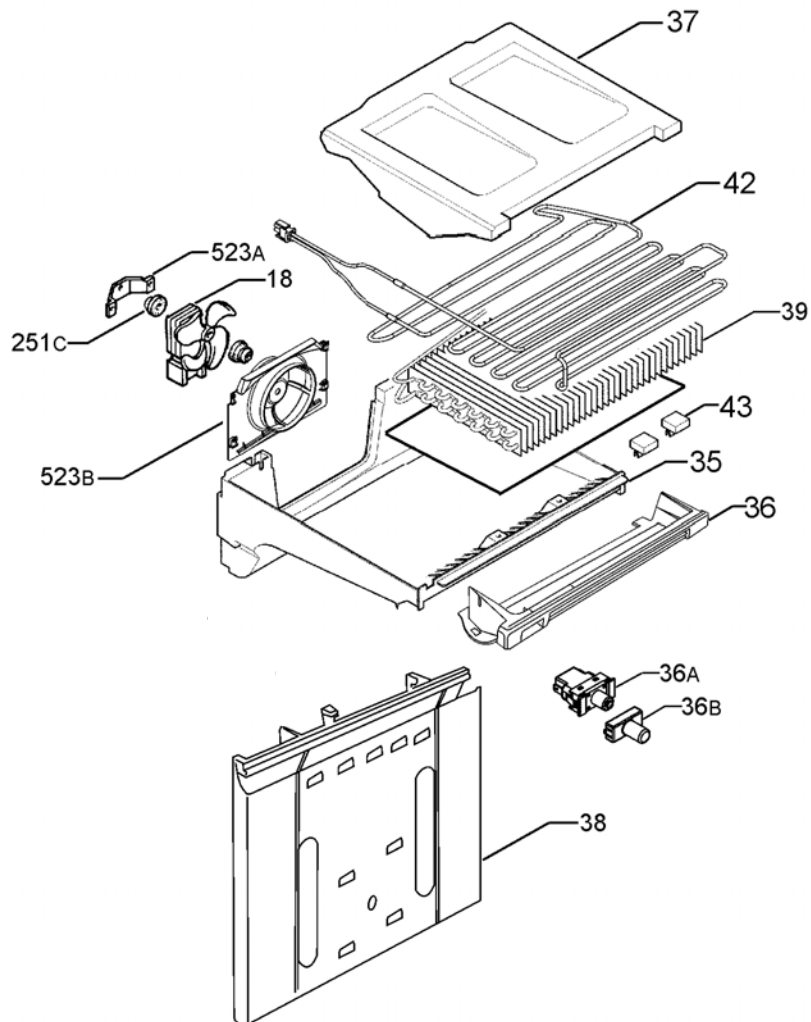
- Temperature fluctuations in the refrigerator compartment

This defect is caused by an insufficient flow of air generated by the battery evaporator fan (pos. 18).

In order to eliminate this defect, it is necessary to replace the battery evaporator fan with a more powerful version (2,500 rpm) (part number 2260065376).

The new fan is more noisy in operation than the original version.

N.B. The new fan must be used exclusively to eliminate temperature fluctuations; if the original fan is faulty, use the old part number when replacing.
