Dometic GmbH, In der Steinwiese 16, D-57074 Siegen

B1600plus, B2200

Fan works with maximum speed

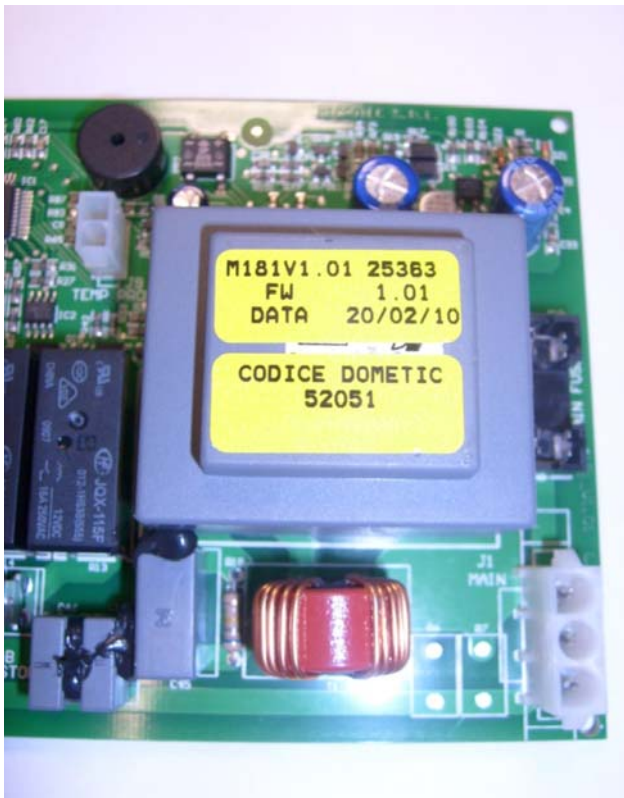
“DATA 20/02/10” is the production date. Electronics produced between 09/12/09 and 20/02/10 could be involved.

The reason of this failure could be caused by the electronics, which has to be exchanged in this case.

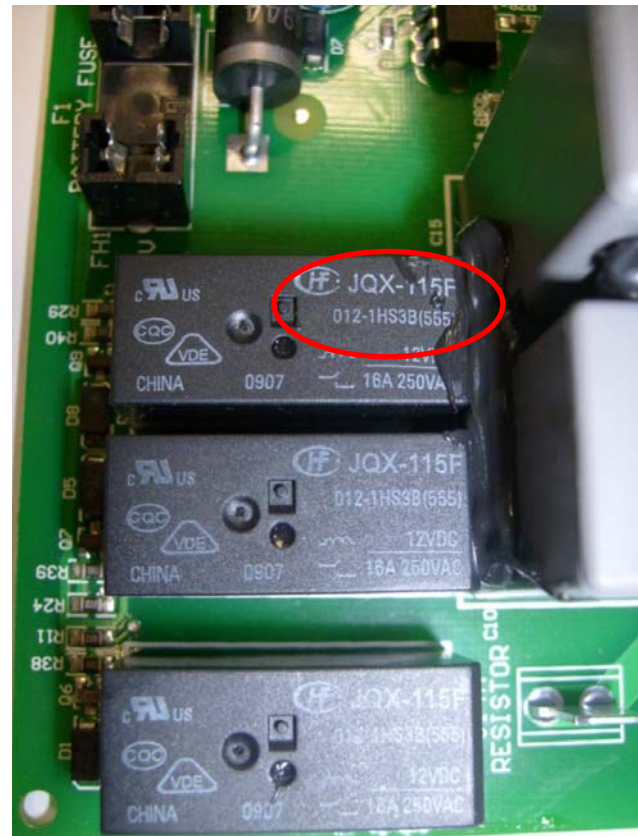
The lettering on the relay “JQX-115F-012-1HS3**B**” shows the wrong relay.

The correct relays show one of the following lettering:

HF115F 012-1HS3

JQX-115F 012-1HS3 (xxx)- without letter “**B**”

HF-115F 012-1HS3B
