TOP ICING/CONDENSATION IN CT REFRIGERATORS

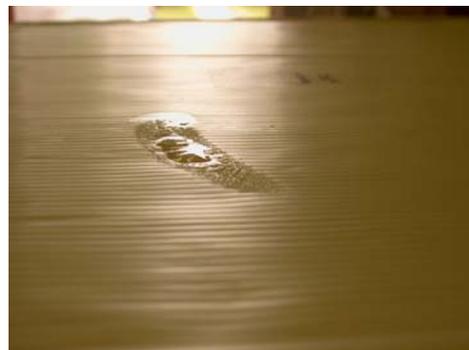
Sometimes at the top cover of CT refrigerators appears icing/condensation, mainly when the relative humidity in the air is quite high. After remove the top cover is visible the following:

B, if there is permanent icing on the top (see the photo above), the suction line is too close to the top, it must be set right and re-insulate for repairing. See the following process.
