DEFROSTING CONDENSATION HAVING DIFFICULTY FLOWING

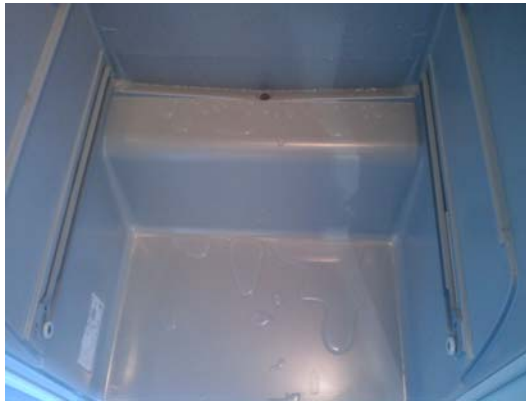
In relation to the 340 Cooler BI Dod/Sd appliances listed in Table A, in certain environmental and installation conditions, there may be an excessive formation of condensation, which has difficulty flowing correctly into the water drain hole.

This fault may occur because the drawer runners are fastened too far forward, causing the drawer to touch against the bottom of the compartment and preventing the condensation - during refrigerator defrosting operations - from flowing into the water drain hole.

To remedy this fault, simply fasten the runners in a different position.

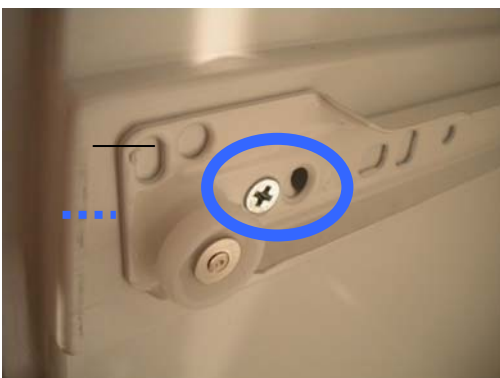
1. Check whether the runner is fastened to the first hole.
