**INTERMITTENT PROBLEMS WITH FAILURE OF USER INTERFACE
ON INDUCTION HOBS WITH CHEETAH MODULE**

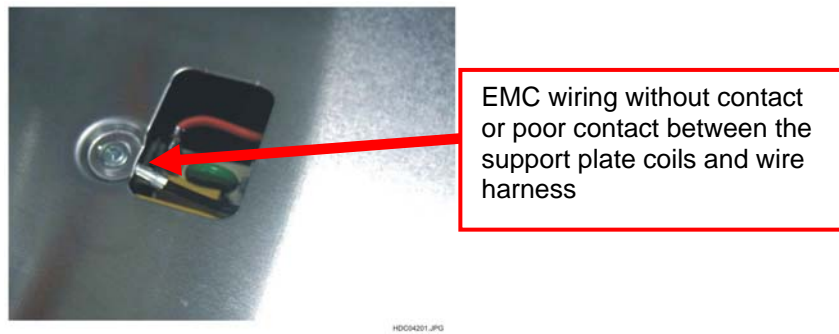
Fig. 1

The problem occurs with the cooking area that can automatically turn on or off during cooking. Touch might not have any reaction during the cooking function and high power settings.

Main cause: The wiring of EMC shield with loose contact (non-contact or intermittent contact), between the electronic board and support coils of sheet metal.

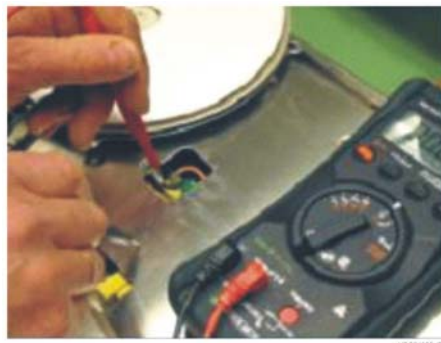
Fig. 5

If the wiring EMC is already mounted on top of the support plate coils between screw and support:

Make sure there is contact between the ring terminal and the coil support plate (should be 0 ohms), anyway tighten the screw terminal.
