FIXING OF THE COOLING CHANNEL WRONG

When the fixing of the cooling channel in the built-in ovens products in DGT Factory (range of PNC 944 and 940) is incorrect may experience problems with over heating symptoms described below.

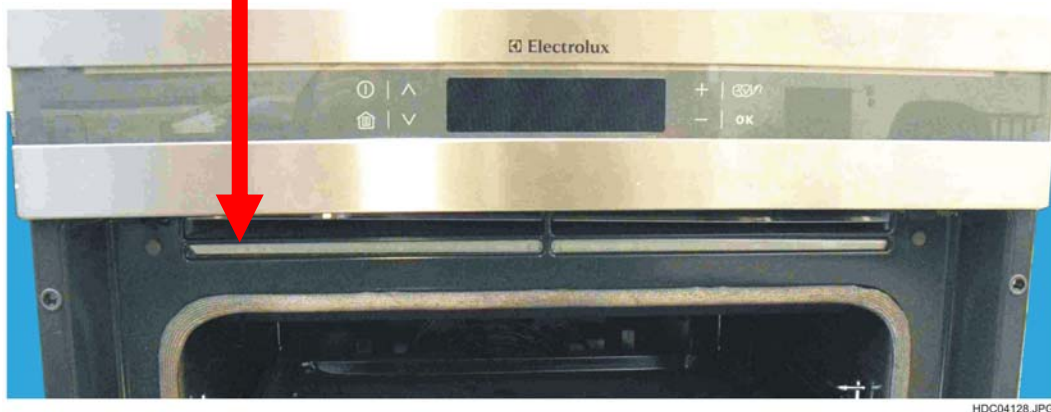
Fixation of the cooling channel with the front frame it out of position or lopsidedly fixed, visible above the door (Helpful the use of a lamp).

1. BO-door is leaky concerning the higher internal Cavity pressure.
2. Electronics and housings of electronics on the panel area are burnt or melted.
3. Switch of the over temperature (Klixon) on the cooling channel are switch on and turn off the heaters.
4. Baking result is not satisfactory for the consumer.
5. F6-error in the display by ovens with electronic.
6. Door cover is melted frequently by pyro function.
7. Condensation shown in the display of the user interfaces or could be to in the glassed of the door.
8. Front temperature of panel and/ or door is to high.

Demount the screws of the bottom of the cooling channel in the cavity, take care of an new correct fixation of the channel in the front frame and fix the screws of the channel bottom again.
