### Uncertain function of light switch

Base model TT160CMX (below PNC's) can be involved.

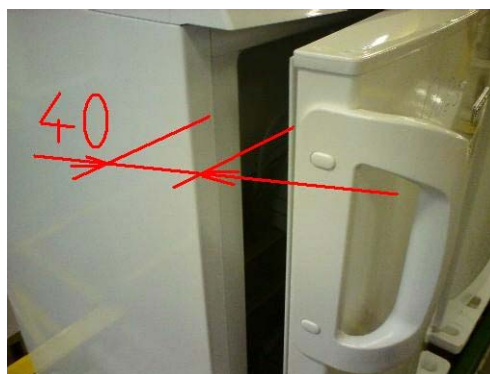
1. Check the safety lamp unit function. Measure the distance between side panel and door panel when lamp light on/off:
  - a. Over or equal to 40mm = OK
  - b. Less than 40mm = NOT OK; It's needed to modify the lamp unit position according to following instructions
