**TEMPERATURE FLUCTUATION**

**DESCRIPTION:**

In relation to the equipment listed in Table A, (385 Cooler Dy) excluding those with the ERF2001 circuit board, temperature fluctuation and warm refrigerator phenomena can occur.

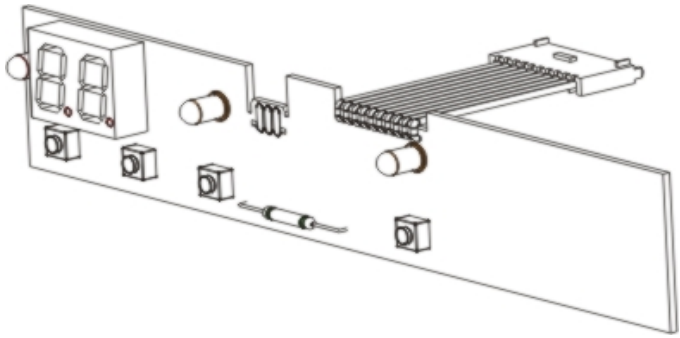
**AEG**

Board with problems	Board to be ordered

242515820-7	242515838-9	
242515833-0		
242515837-1
