DRUM ROTATION BELT BROKEN

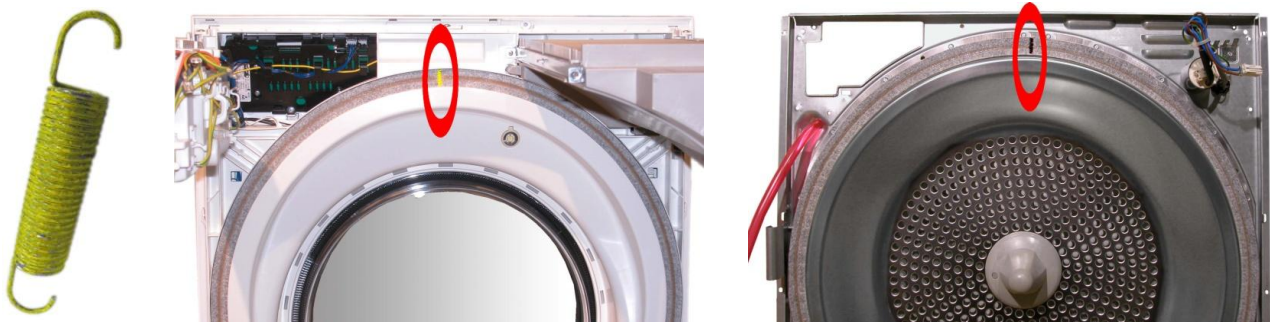
The problem is caused by the fact that the two sponge seals, one located in the front air conduit and the other located on the back panel, place excessive pressure on the drum increasing the force needed for rotation which subsequently causes the belt to break.

The problem is definitively eliminated by replacing not only the belt damaged, but also the spring that maintains the motor in traction, is possible to recognize the new one because it have the yellow color, and the 2 sponge seals with new ones that can instantly be recognized by the seam shown below.

Spring Motor	136653300-6	spring yellow
Rear seal	136808920-5	blu seam
Front seal	136808930-4	yellow seam
Drum rotating belt	fit the belt shown in the spare parts catalogue.
