SERVICE BULLETIN

Dometic GmbH, In der Steinwiese 16, D-57074 Siegen

RM/S 8500/01/05/50/51/55, RMD/T 8501/8505/8551/8555

Change position of door locking device

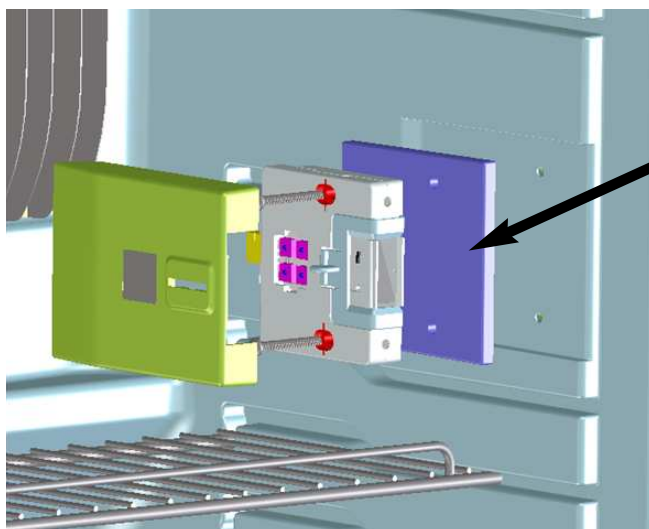
pic 3

In above mentioned fridges the position of the latch has changed (pic. 1+2).
If the door of one of these models will be exchanged, a space plate (spare part number 295 1973-20/1) has to be installed under the door lock (pic. 3).

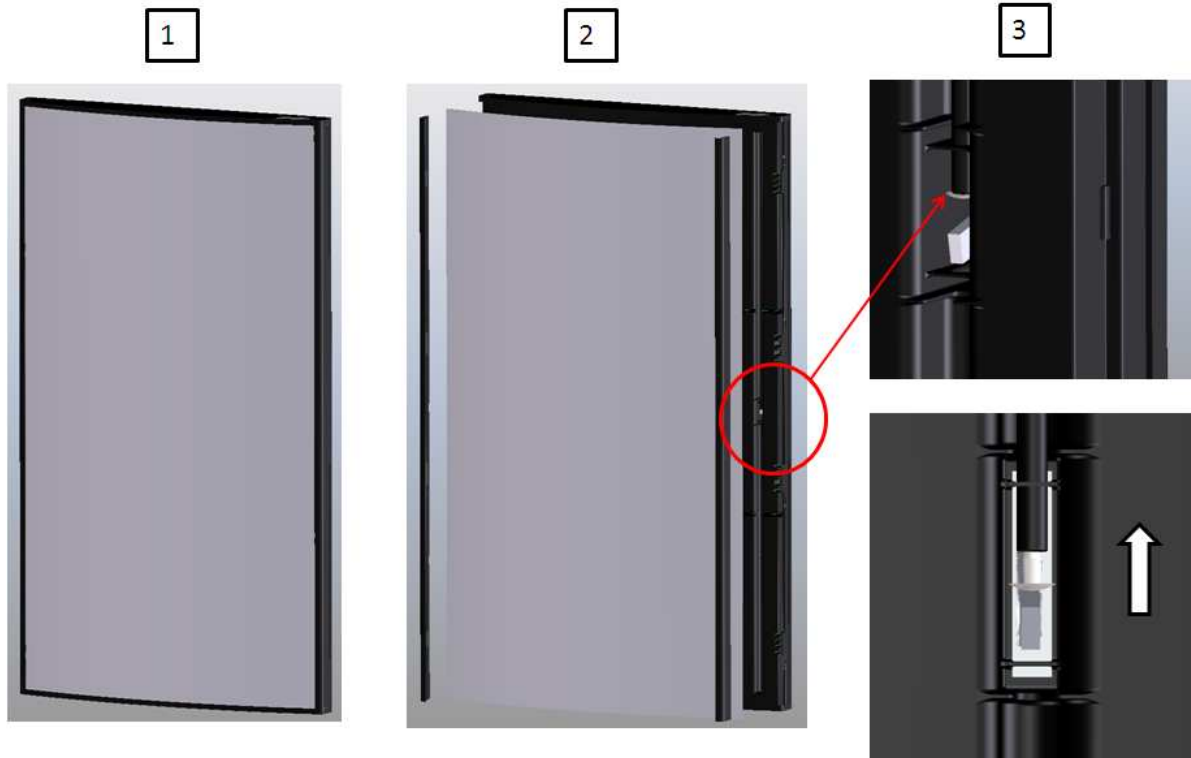
Door with frame

In above mentioned fridges the activation rod can get stuck. In this case, please install the expanding rivet (spare part number 292 3142-06/7 (1 piece) or 241 2559-17/7 (5 pieces)).

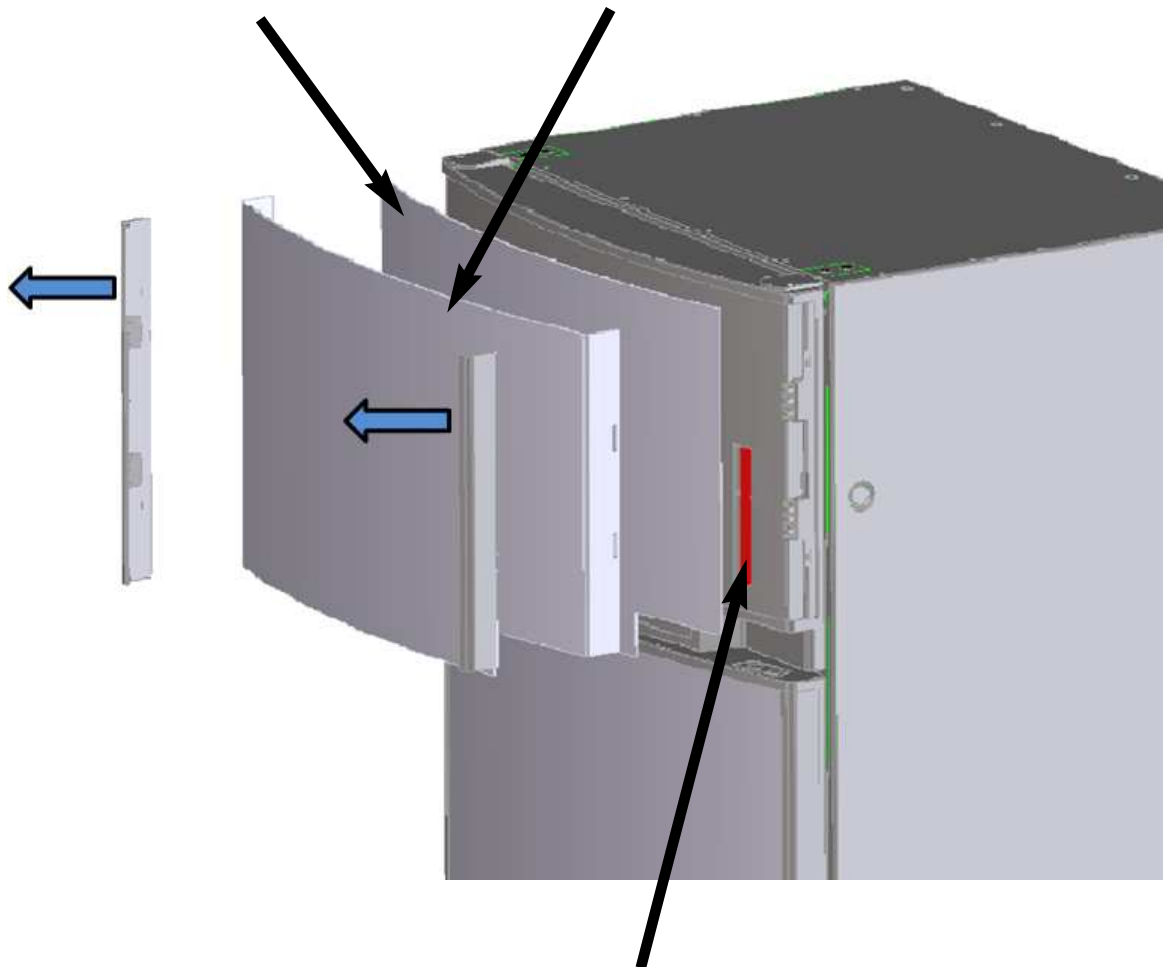
Insulation strip 293 5688-21/4

In above mentioned fridges condensed water can arise on the decoration panel and the door locking device can be frozen. In this case please install insulation strip (spare part number 293 5688-21/4).

Version with cover strip

Take off the cover strips and push the decoration plate up and take it away.

Version without cover strip

Push the decoration plate to the left side and take it away.
