**DESCRIPTION OF LEAKS FROM SOLDERED JOINTS IN COMPRESSOR
COMPARTMENT**

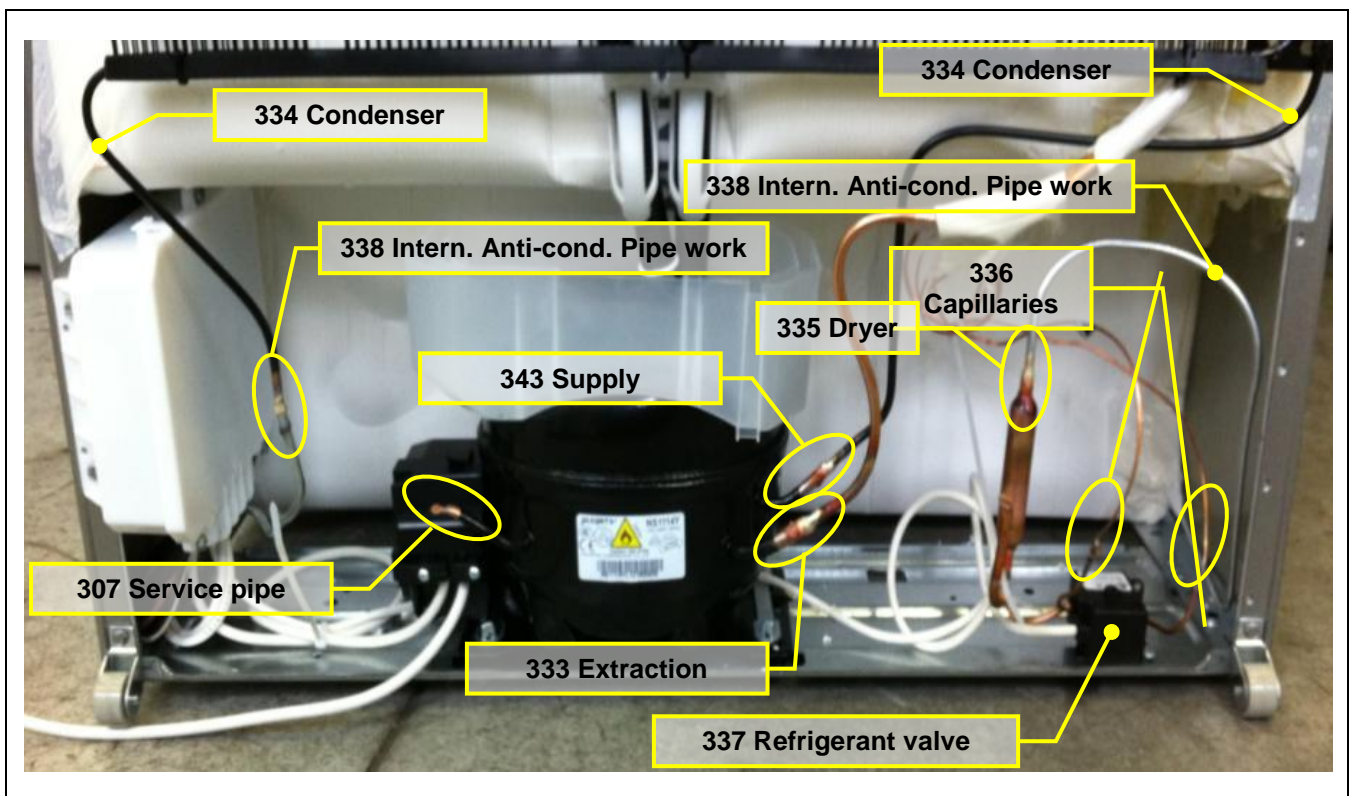
Sometimes there can be leaks in the compressor compartment caused by soldered joints that start leaking due to vibrations or for some other reason. These leaks are added to the QES system via numbers and this Service Bulletin helps the technician to add in this data.

QES Code	Description
307	Service pipe
333	Vacuuming
334	Condenser
335	Dryer
336	Capillaries
337	Refrigerant valve
338	Intern. Anti-cond pipe work
343	Supply

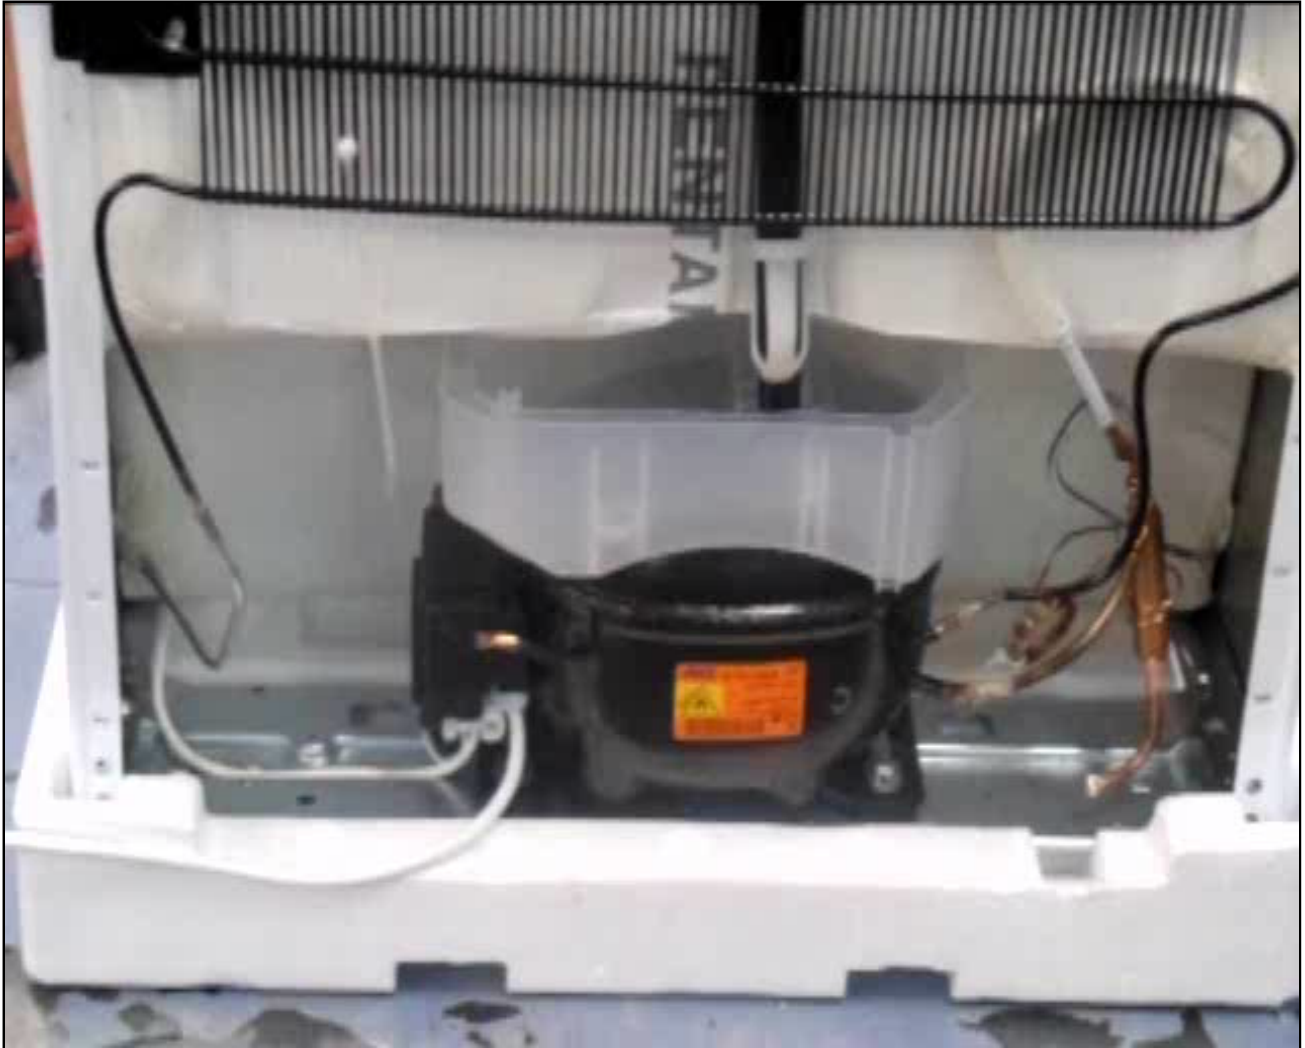
With this video we want to show the joints where dwell to check for leaks of refrigerant gas

The control must be performed with a tool adapted to detect leaks of refrigerant gas being careful to verify all joints, making sure to test the entire circumference of the fitting, and very importantly, the duration of each measurement for each joint must not be less than 5 seconds.
