SERVICE INSTRUCTION FOR IMPROVED TIGHTNESS, VALID FOR ALL MICROWAVE COMPACT APPLIANCES, BEGINNIN IN 2005 UNTIL S.N. 2 36 30249

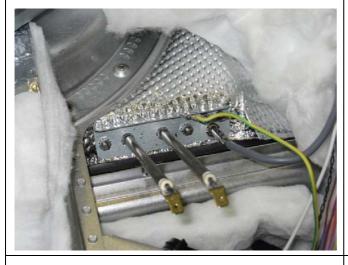
State of origin, white insulation carefully pushed aside.

Loosen nuts for L-flange and PT500 sensor (will be used again). Remove L-flange and pull cable of the PT500 sensor carefully through the cavity hole.
