Product: CSE, see the PNC list at the end of document.

Defect: Humming Symptom - The motor work very slowly also if it is turned off.

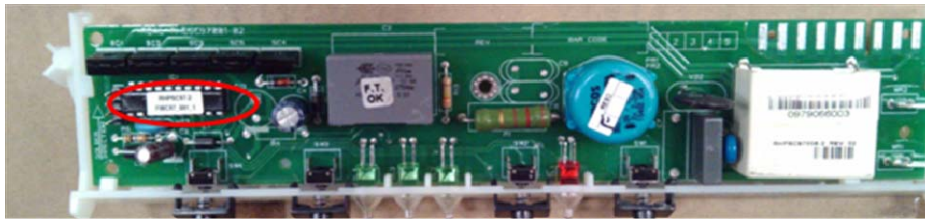
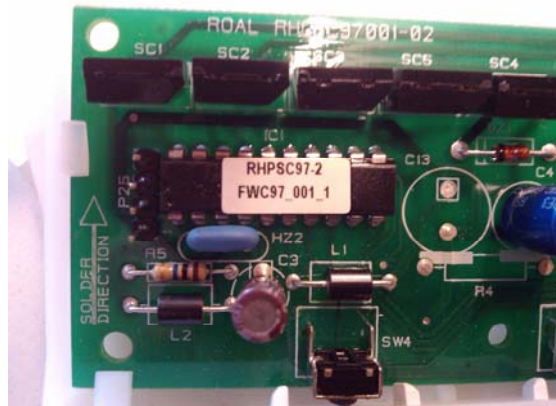
A

- A) OLD Motor group. PNC listed below.
It is also recognizable by sub-supplier code RHPSC97-2. Picture A.
- B) NEW Motor group. PNC listed below.
It is also recognizable by sub-supplier code RHPSC97-4 (hardware modification) and FWC97_001_2 (software modification). Picture B.

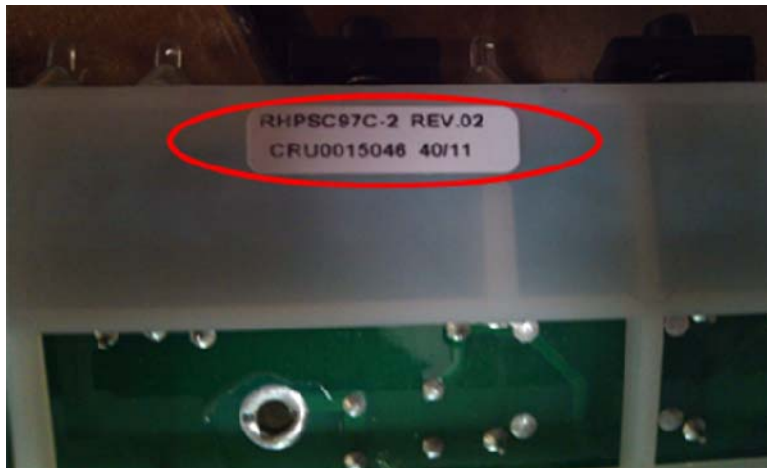
C

There are two existent PCB for this model and Elica BOM is readable on the plastic support (picture C). They are very similar, but they aren't interchangeable.
