### DOOR COVER BOTTOM WITH ADD GASKET TO EVOID STEAM INSIDE THE DOOR ON APOLLO

This service instruction for assembling the door cover bottom with the additional gasket (spare part kit **561 83 15-26/0**), is valid for all Apollo Steamer from serial start **(2012)** until **3 10 20224 (2013)**.

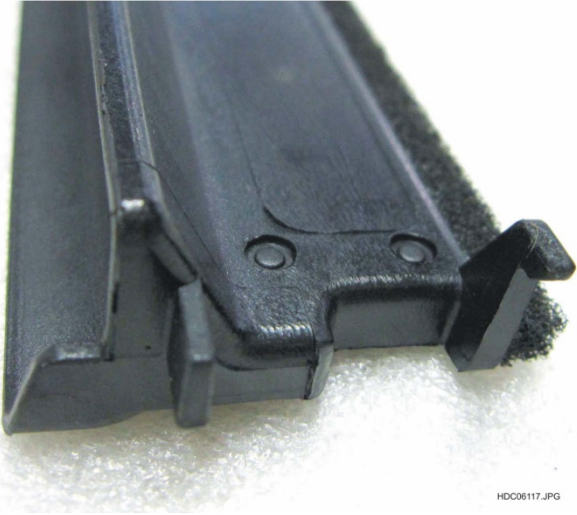
<p style="text-align: center;">HDC06117.JPG</p> <p>Fig. 1</p>

Door cover bottom, original state (Code <b>387 92 24-21/4</b> )	Door cover bottom, modified with additional gasket (Code <b>561 83 15-26/0</b> )

1. Unhinge the door and open according guideline.
2. Change original door cover bottom against the new one with the additional gasket (see Fig. 1 and 2). Pay attention not to displace the gasket.
3. Carefully reassemble the door, mount the door in the oven and proceed with the functional test.
