SERVICE BULLETIN REFRIGERATION

ICE BUILD UP IN FREEZER COMPARTMENT.

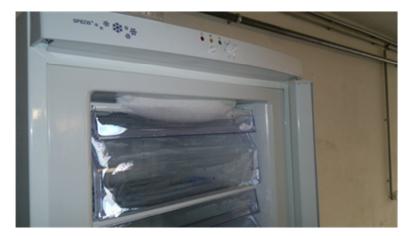
Ice is building up in top part of freezer compartment due to insufficient sealing.

Curved inner liner corner. Possible cause of excessive icing.

Check the door closing. If the gasket does not adhere correctly on its full length, it has to be replaced by new one. In case where there is a deformation or damaging to the door, entire door has to be exchanged. If the gasket is fine and underpressure is forming inside closed cabinet, but the ice is still forming, then additional sealing is required.
