LEAKAGE FROM THE BACK OF YOT TOP LOADED WASHING MACHINE.

All YOT top loaded washing machines.

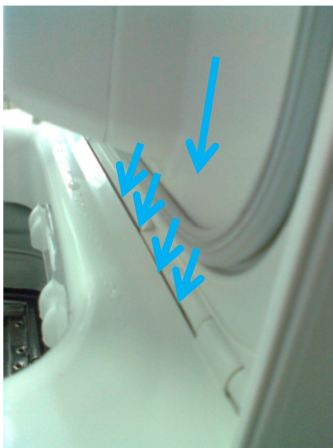
After finishing the cycle and opening of lid cover some water remains from lid innerliner may drip through gap between hopper and lid cover. Water then accumulates in drip tray area under electric valve. After several subsequent washing cycles water level in drip tray may rise. This can lead to overflow through the hole in back of appliance.

Water dripping way.

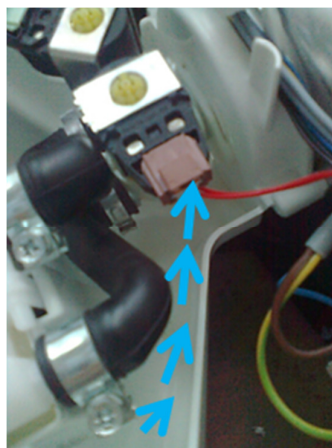
Water drip tray area.

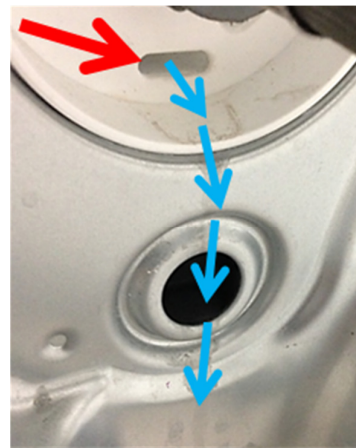
Leakage through back side of appliance.
