WELDED WASHING GROUP EXCHANGE. E20 ALARM ON DISPLAY. WATER DRAINAGE NOT WORKING.

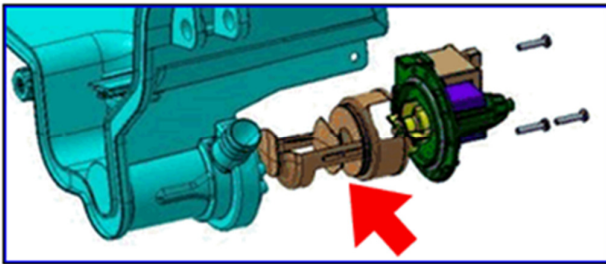
If there is no particle filter in washing group water will not be drained and E20 alarm will appear on display.

1. Particle filter position.

During exchange of welded washing group with integrated pump body it is necessary to move filter from old WG to new one.

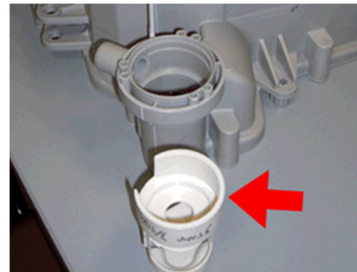
2. Filter extracted from pump body.

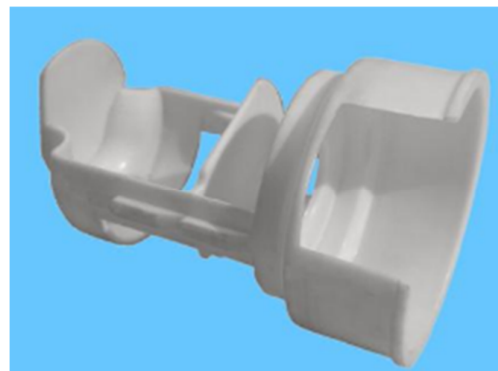
4. On the side of filter there are guidelines to allow easier assembly and prevent incorrect insertion.
