RMD 8501/8505/8551/8555, RMDM 8501/05/51/55,
RMDT 8501/8505/8551/8555

Ice formation on the freezer door

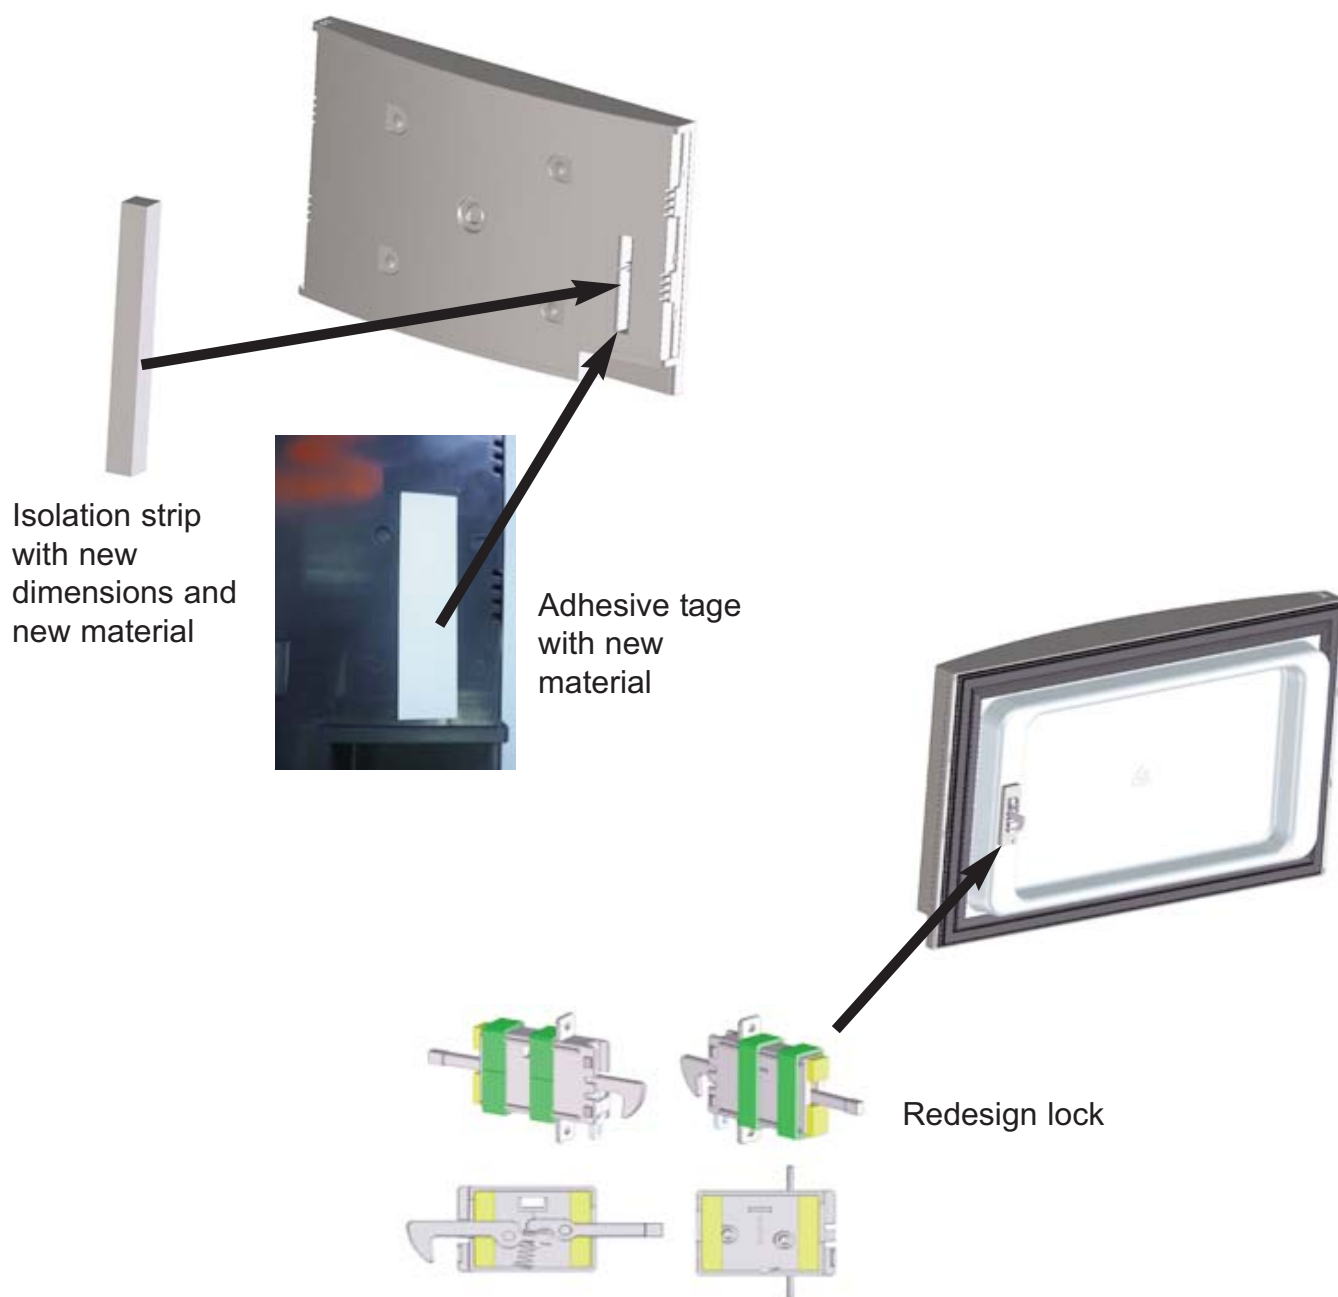
In above mentioned fridges condensed water can arise on the decoration panel and the door locking device can be frozen.

This new Servicekit will solved this problem.

The Servicekit, spare part no. 241 2350-95/7, contains a isolation strip, an adhesive tape, and a redesign lock.
