WRONG SCREW IN OPTIONAL PACK

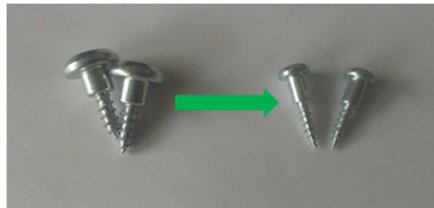
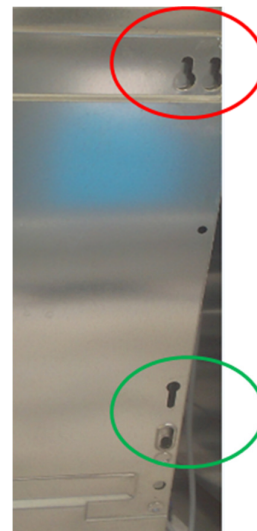
We would like to inform that from week **11/2015** factory has modified outer doors. Two holes for fixing screws have been removed. Due to this only lower holes should be used to position the wooden panel.

From week **11/2015** to week **24/2015** factory produced dishwashers with wrong optional pack (wrong screw - **4,5x18** instead of **3,5x19**) and drilling template (holes for screw in incorrect positions).
