### LEAKAGE FROM UNDERNEATH THE YOT TYPE TOP LOADED WASHING MACHINE.

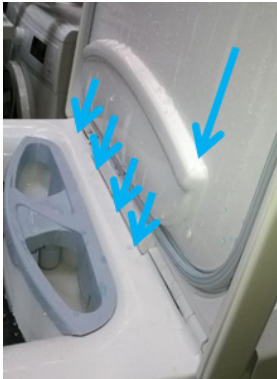
When the lid is opened, after the end of washing cycle, residual water may drip from lid's innerliner into the gap between lid and top part (Photo 1). Then it flows to the water gutter under control panel (Photo 2). After several consequent cycles it may cause water accumulation, leading to overflow (Picture 3) through hole to the bottom of appliance.

Photo1. Water dripping from opened lid into the gap between top part and lid.

The gap between top part and water distributor has to be sealed.

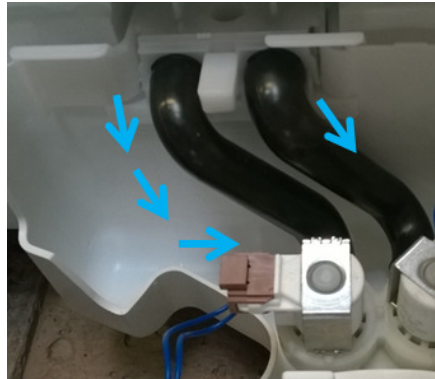
Photo2. Water gutter.

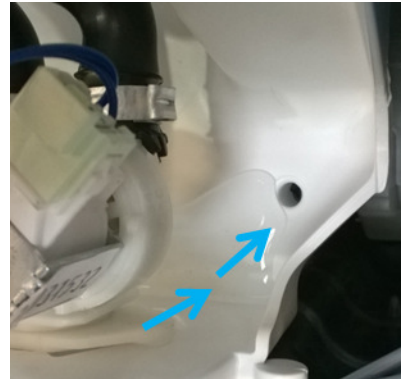
Photo3. Leakage through hole in gutter.
