Dometic GmbH, In der Steinwiese 16, D-57074 Siegen

FJ 1100, FJ 1700, FJ 2200

Creation of water condensation

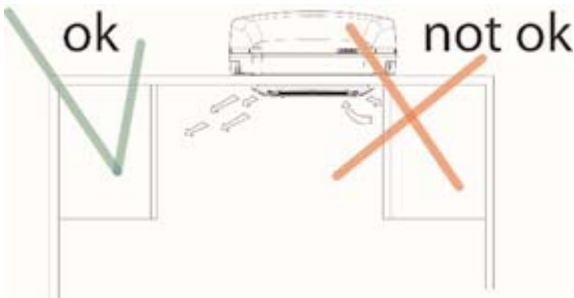
fig. 1

- Operating error: The choosen target temperatur is very low. The air conditioner is in continuous operating (e.g. choosen 18°C if the outside temperature is 38°C).
- Faulty sealing between air distribution box and roof top part.
- Open door and windows.
- Wrong installation of the air conditioner. The air can't circulate in the right way (fig. 1).

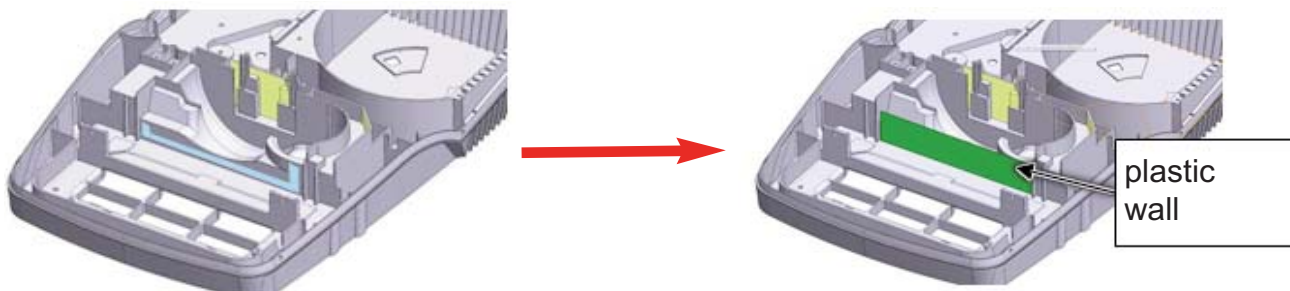
fig. 2

This can be validated by the plastic wall in the front of the air conditioner (fig. 2 + 3). If this plastic wall is missing, the kits 1 (81-BB-36601) and 2 (81-B-36602) must be installed to avoid ice formation on the evaporator (fig. 3) and the creation of a lot of condensation water on the fan (fig. 4).

The condensation kits 1 (81-BB-36601) and 2 (81-B-36602) can be ordered via the Dometic sales companies.

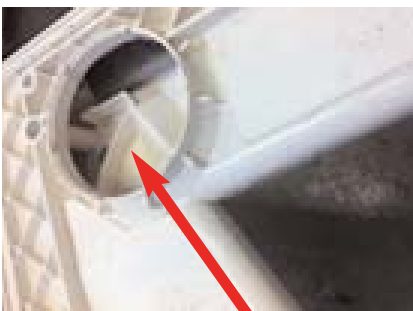
fig. 5

For air conditioners having water condensation on the air distribution box (fig. 6) it must be checked if the sealing (fig. 5) is installed. Otherwise add the sealing 386 3502-16/1.

Furthermore the condensation kit 2 (81-B-36602) must be installed.
