TOO EARLY INTAKE OF SOFTENER AND/OR RESIDUAL WATER LEFT IN SOFTENER COMPARTMENT AFTER WASHING CYCLE.

EN SDT – KL 1/2 599 79 53-39 Rev.00

All top loaded Claudia type washing machines.

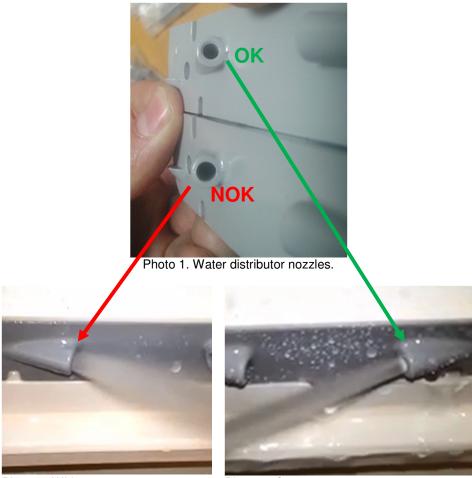
Problem may be caused by too big diameter of water distributor's nozzle. Bigger diameter of nozzle forms wider water stream. This causes incorrect water distribution. Water goes to central compartment too early or remains in central compartment after rinse cycle.

Photo 2. Wider water stream.

Photo 3. Correct water stream.

2. Measure diameter of water distributor nozzle. (Ømin= 3,90; Ømax= 4,0)

3. If the diameter is greater than 4.0 replace water distributor (for details please refer to service manual).
