Error E9 or switching errors on Pelican user interface

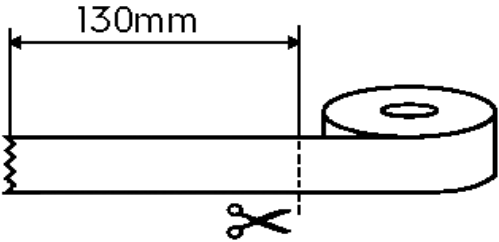
During operation of a radiant heater, rise of temperature may cause a rise of humidity level. If the humidity enters the Everest protection box, it condenses and causes malfunctions. This can be observed as either an E9 error or various errors switching on the display

<p>1. Remove the power board protection box from the appliance. Be careful not to lose the springs.</p>	<p>2. Locate ventilation holes on the bottom.</p>
