**ICING IN MULTIFLOW COVER PREVENTION
466 COMBI NO FROST PRODUCTS****DESCRIPTION:**

PNC/MODEL:

PNC	Model
925993134	EN4084JOX
925993136	S74010CMX2
925993144	S74011CMX2

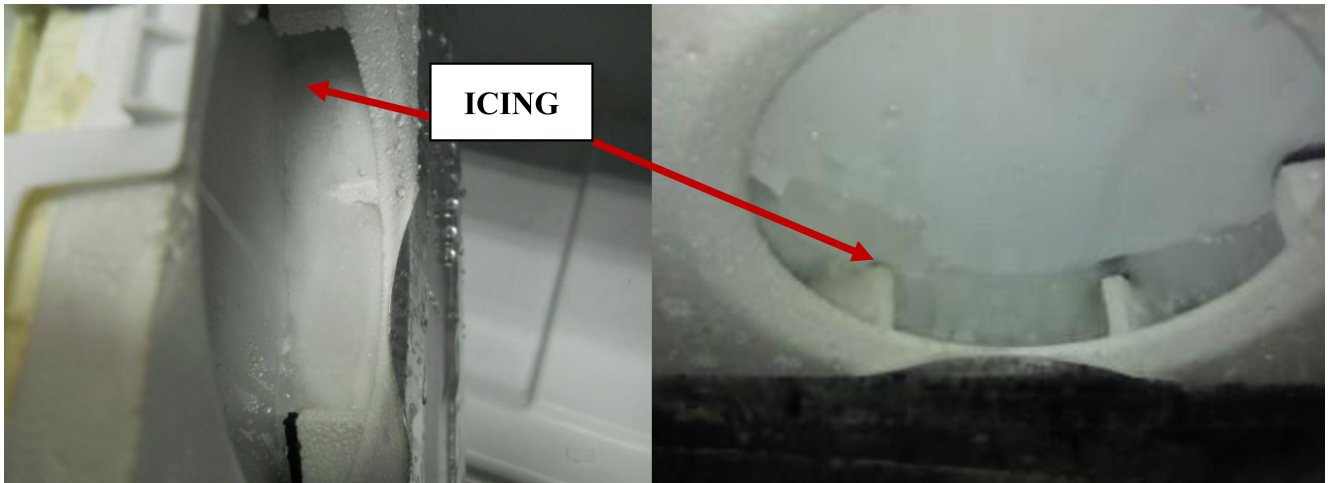
Photo -1

- Icing between the freezer multiflow plastic and the Styrofoam (Photo 1-2)
- Icing among the blowing hole of the multiflow (Photo -3)
- Running noisy the propeller by rubbing to the ice because of icing at the multiflow (Photo-4)
- The insufficient cooling because of the propeller not running

Only serial numbers before 546xxxx are affected by cold module ice built issue.
PCB with new software was implemented in production on week 46 2015.

In case of observing events below, please melt the whole ice completely.
After that, please replace the new mainboard and the multiflow 4055343364.
