Ice build-up on freezer compartment of Combi Bottom Static

# SERVICE BULLETIN REFRIGERATION BUILT IN COMBI BOTTOM

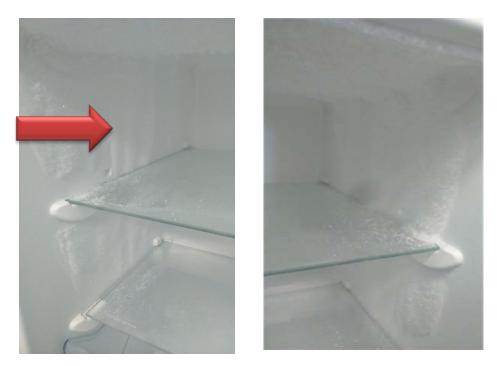
The ice formation in the freezer compartment is around the inner liner; see the tubes in the photo, not behind the drawers as in the past.

## Example of "normal" ice formation in the freezer compartment
