### GLASS PANEL SLIGHTLY DROPS DOWN AFFECTING HOOD ON/OFF SWITCH

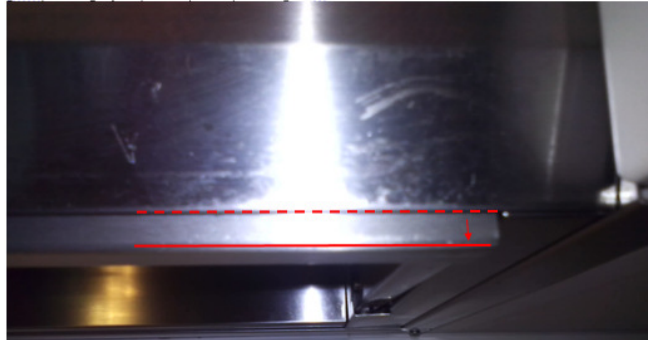
The glass panel drifts down and does not close well, affecting hood on/off switch (light and fan are on even in closed panel position).

Introduction of magnet and gasket on the side covers, left and right (see images below).

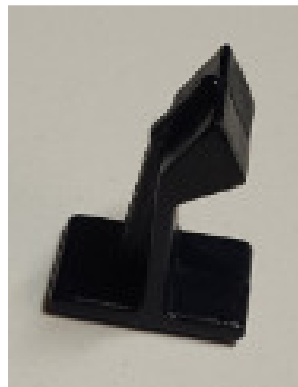
Plastic material of the component inside Sklock mechanism is not able to withstand the glass panel weight in cooking conditions (high humidity & temperature) and deforms over time.
