Main oven flame outage

DESCRIPTION:

Main Oven Flame goes out during use. The main reason is associated with wrong ventilation in oven caused insulation moving and starving the burner of air.

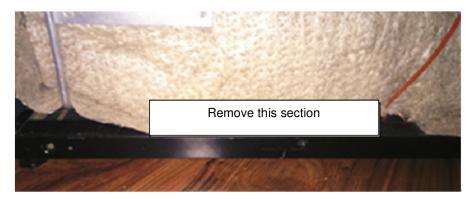
Use scissors or a knife taking care not to damage the HT lead or thermocouple. Remove approximately 25mm x length of the burner of insulation. Remove a section of insulation from the rear oven cavity pad making the rear of the burner visible.

This provides a clear view of the burner rear when the back panel is removed.
