E73 alarm (Input drying NTC failure) on Washer Dryer

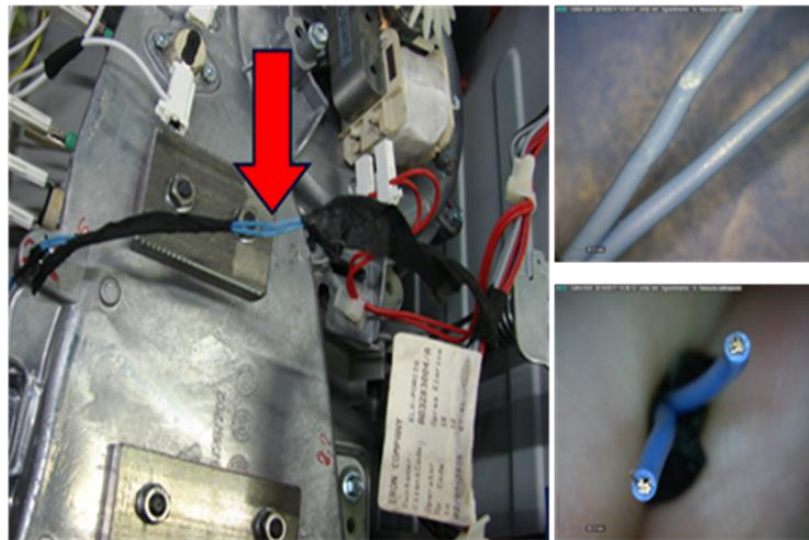
Due to a too relatively thin diameter of the DRY NTC cable, "E73" alarm can happens during the life of the washer dryer. Except for rare cases (to evaluate one to one), it is due to the DRY NTC cable broken/damaged under the black protection tape (especially near the clamp to fix the wiring to the dry aluminium duct).

To solve the issue technicians have to remove the DRY NTC wiring (code A03340702 – SP code 140033407028) and they have to order and replace it with this two new one:

- 1) Harness, temperature probe, 470mm code A06748802 – Spare Part code 140067488019;
- 2) Harness, main electronic board, temperature probe, 1760mm+570mm code A06748701 – Spare Part code 140067487011.

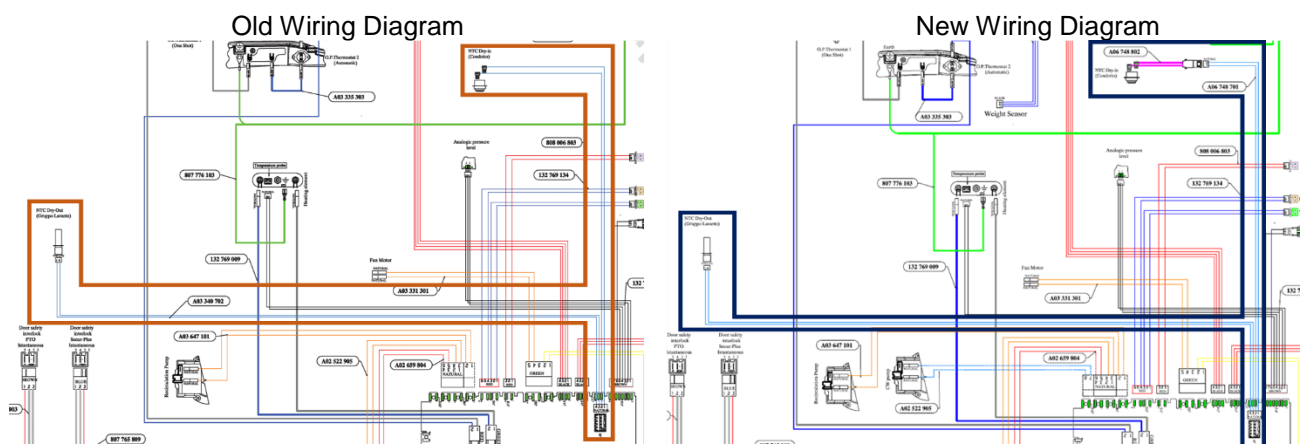
Here below one example of the old wiring diagram and the new one:
