Comfort Lift: I30 Alarm

DESCRIPTION:

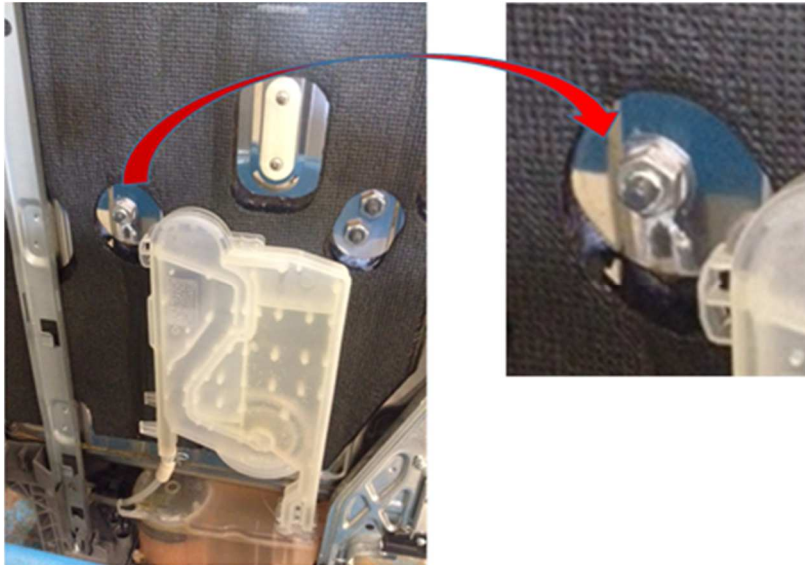
Alarm I30 because of water leakage on the sides of the tub.

Water leakage from the nut of the comfort lift module.

Tighten the nut but also add the Loctite (see below) on the thread. To avoid the same problem in the future add the Loctite on all the threads and tight all the nuts of the module. Use a manual tool not an automatic one (max force torque 4,5Nm).

Since the exterior nuts are metallic and fixed on a plastic part the thread of the plastic part may be damaged in case too much force is used when fixing the nuts.

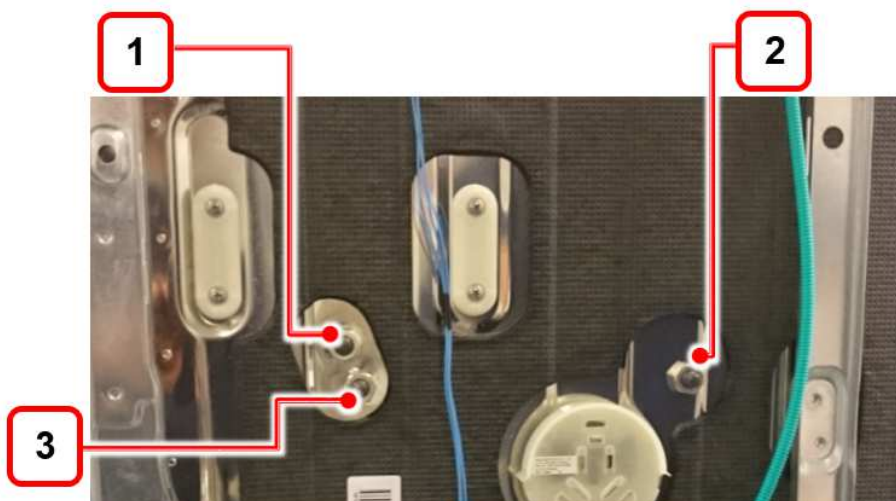
Sequence of tightening the nuts.
