**PROBLEM WITH INEFFICIENT SPIN CYCLE IN FRONT LOADED WASHING MACHINE WITH EWX14
MAINBOARD AND EMC14 MOTOR CONTROL BOARD**

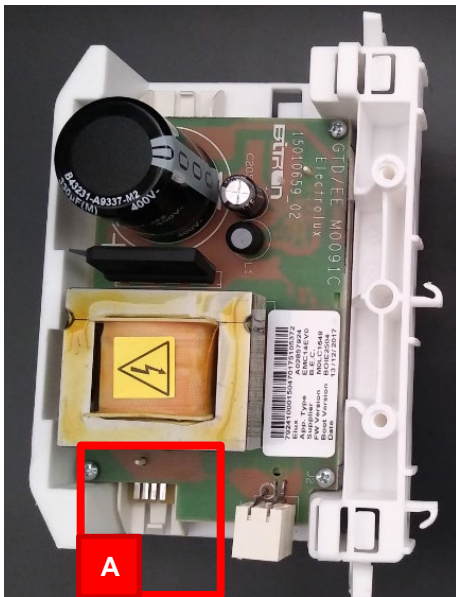
A OLD EMC14 Motor board

After the washing cycle, user notices that clothes are still wet (insufficiently centrifuged). In some cases alarm 'EF5' may be stored in electronic board memory

2 Order and replace below parts (only if [step 1](#) did not solve the issue)

2a Reprogram PCB from previous ELC EMC14 to **ELC EMC18** (see [Table 1](#) in attachment)
