SERVICE BULLETIN REFRIGERATION FS FREEZER

ICE FORMATION IN THE TOP OF THE FREEZER

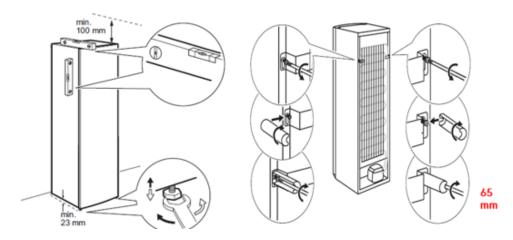
Installation instructions

There is an excess amount of ice formation in the top of the freezer in side-by-side and niche installations.

- Defrost the appliance fully and dry it.
- Check the distance between the appliance and the back wall according to the image below.
 - o There must be gap of 65 mm to the back wall.
 - o Check also the space between the appliance and the furniture at the top and the floor.
