HOB - PELICAN UI BAD REACTION TO TOUCH

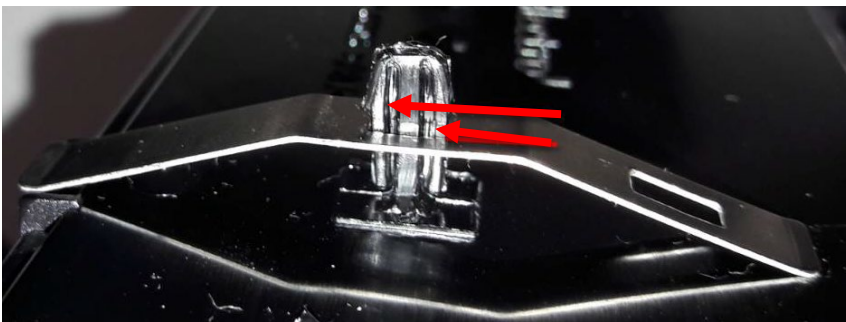
On the UI carrier, a burr on the plastic clip was making the correct assembly of the springs difficult:

(picture of UI carrier plastic clip and spring)

- Check if this is the case and remove the burr to assemble the spring in a correct way.
- Check that the spring is moving freely on the plastic clip.
- Check the force of the spring. If necessary, bend it a little more to have more pressure.
- Make sure UI is in good contact with hob glass

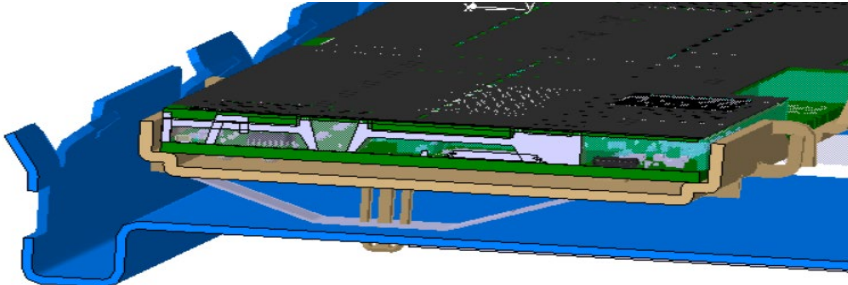
(Assembly view)
