ELECTROLUX HOME PRODUCTS PTY LTD

Technical Bulletin N° CB1029

Ceramic Glass Hob Panel Crack Fault Diagnosis Guide

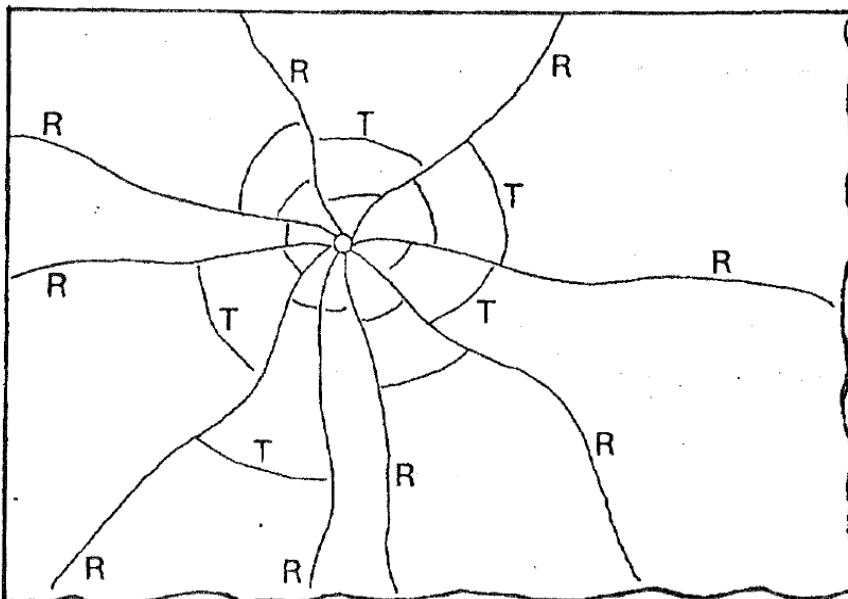
A. IMPACT OR SHOCK

Fracture pattern resembles a spider web. Point of impact is the starting point of many radial cracks which breakup right to the edge.

Can be caused by customer dropping heavy pots/ pans on surface which is not covered under warranty

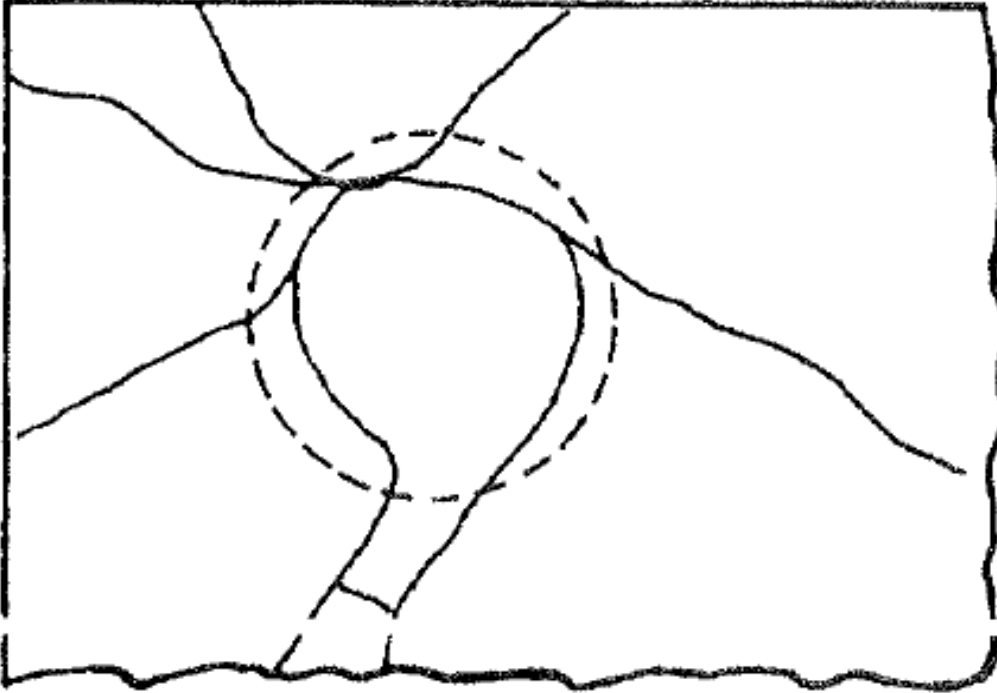
During boiling or cooking

B. OVERHEATING

Customer will likely advise that crack has occurred during or soon after cooking.

If caused by oversized cookware repair is not covered under warranty

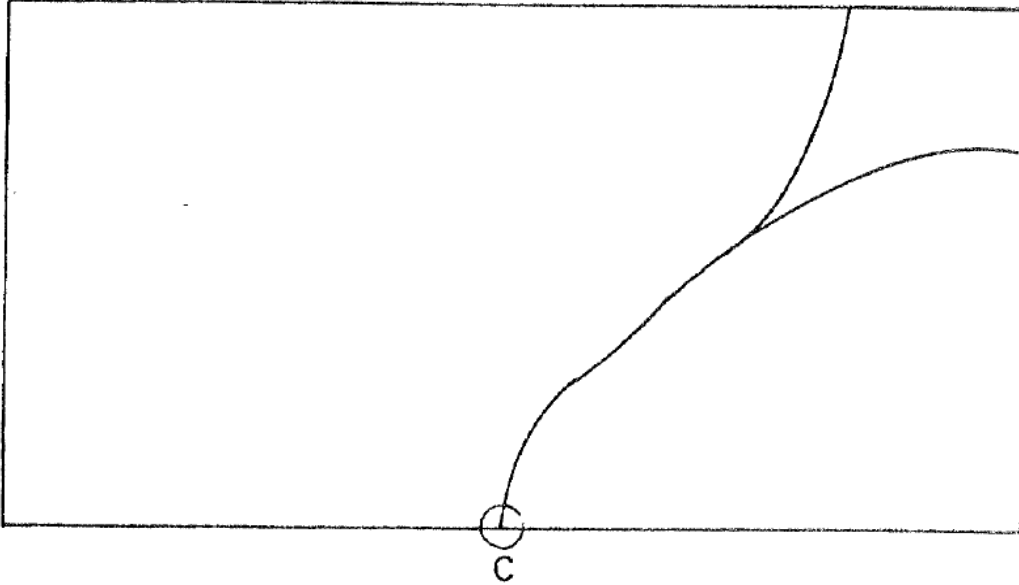
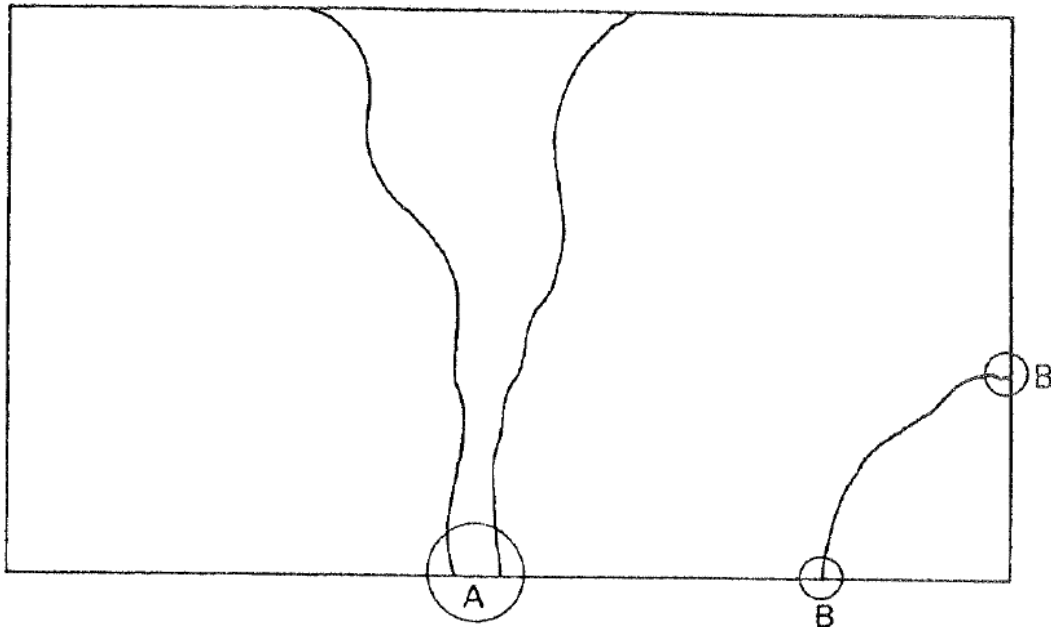
C. COMPRESSION

Can be caused by incorrect mounting of cooktop panel in frame or incorrectly mounting the baseplate to the cooktop frame.

If caused by incorrect installation repair is not covered under warranty

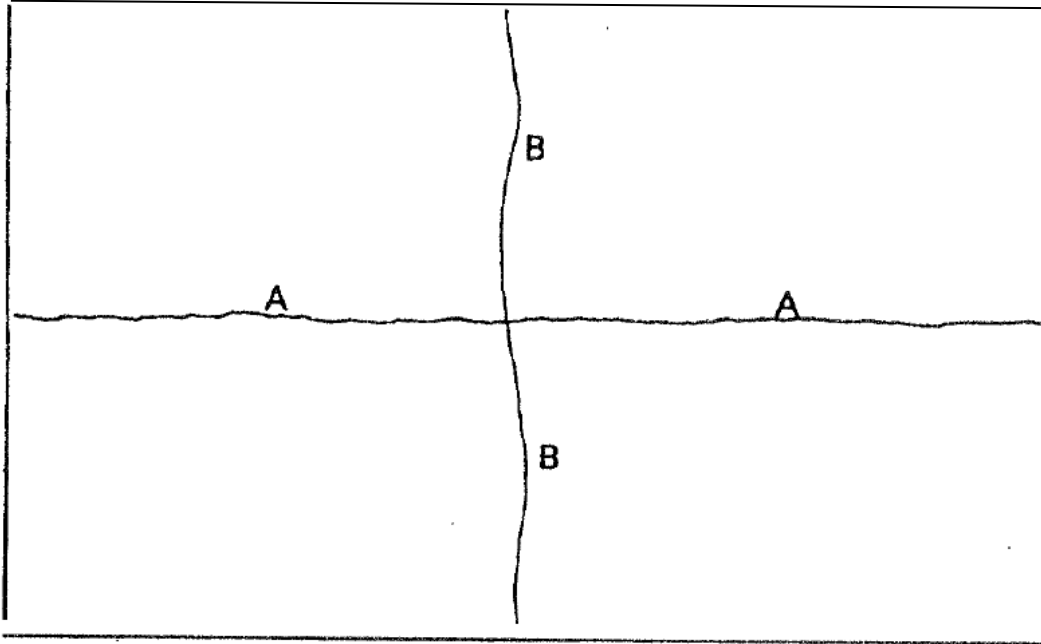
D. COOKTOP GLASS BOWING

Can occur when the size of the bench to cut out has been incorrectly cut and is too small for the cooktop frame, or when the cooktop frame is unevenly supported.

If caused by incorrect installation repair is not covered under warranty

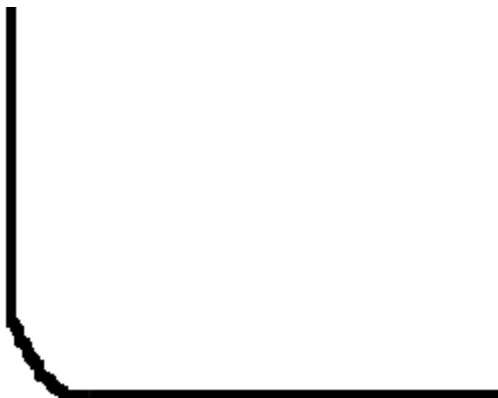
E. CHIPPED CORNERS

Can occur when pots are dragged onto the cooktop surface catching the corners causing chipping.

Not covered under warranty
