Title: Refrigerator Door Misalignment

Detail: The purpose of this service bulletin is to provide the service instruction and part change in order to improve door alignment on refrigerator by adding a washer to level a door.

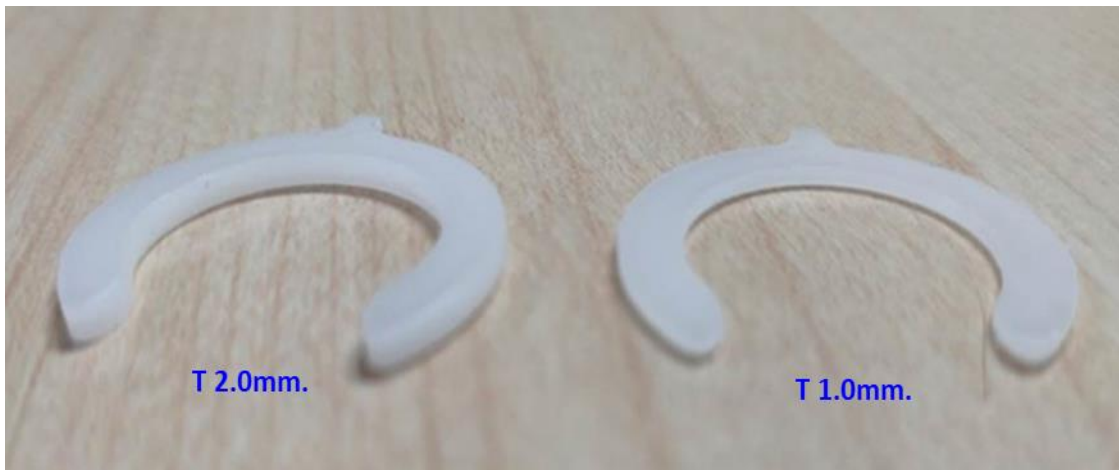
Part No	Description	Serial Number Range	Model
14005956702	Door Levelling Washer, 1.0 mm	all	MDR4 Dingo, Bobcat
14005956703	Door Levelling Washer, 2.0 mm	all	MDR4 Dingo, Bobcat

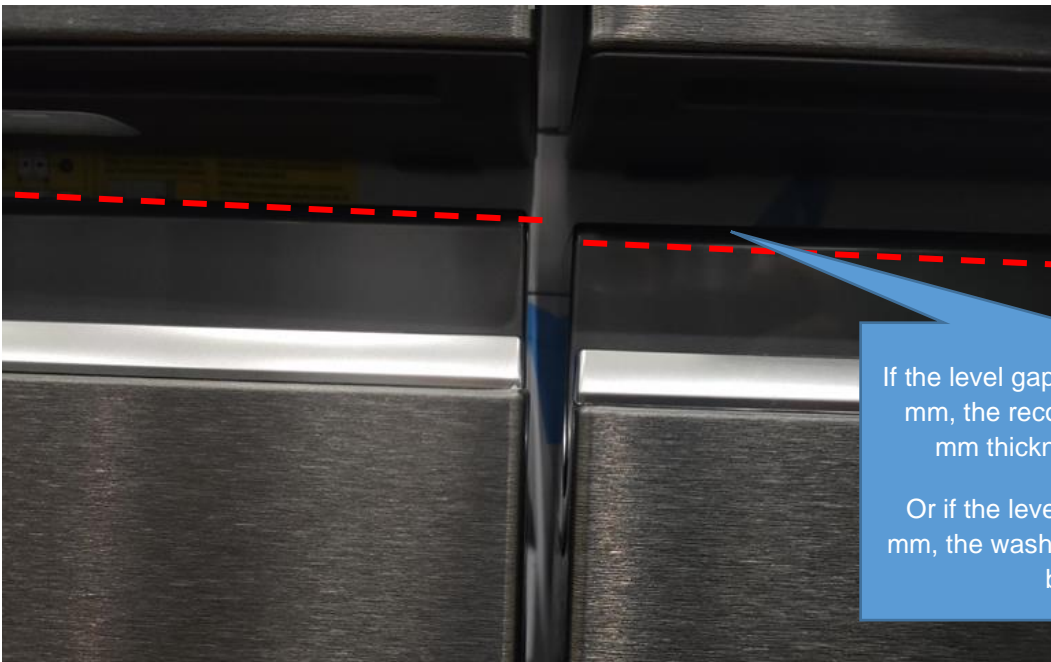
The Refrigerator VCZ and FZ door are not leveled.

If the level gap is obvious larger than 2 mm, the recommended washer 2.0 mm thickness can be applied.

Or if the level gap is less than 2.00 mm, the washer thickness 1.0mm can be applied.
