**SPARE PART REPLACEMENT
CONDENSATION SOLUTION /CHANGE NEW HEATER FLIP MULLION**

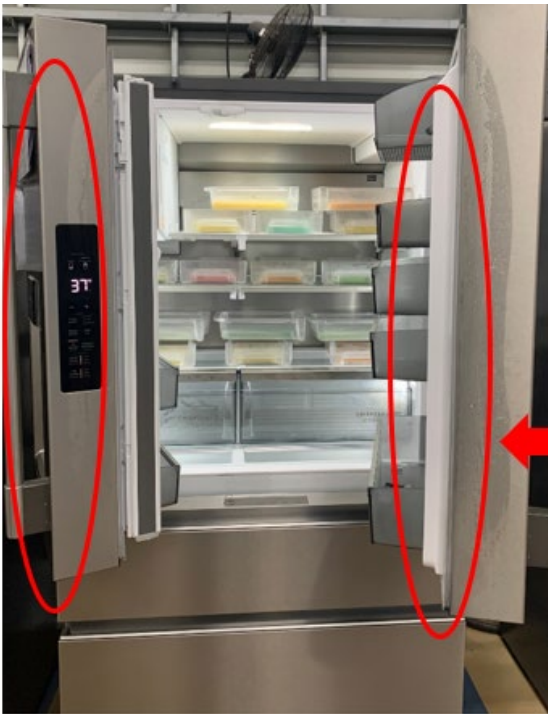
Due to condensation at flip mullion guide and FC door, the heater wiring part number 140045268012 (A04526803) was fold and torn.

Improve new concept locking PVC tube not to move and increase length of PVC and add clip support.
