Electrolux

SERVICE BULLETIN

Caravanrefrigerator

Reg. Nr. 438/96

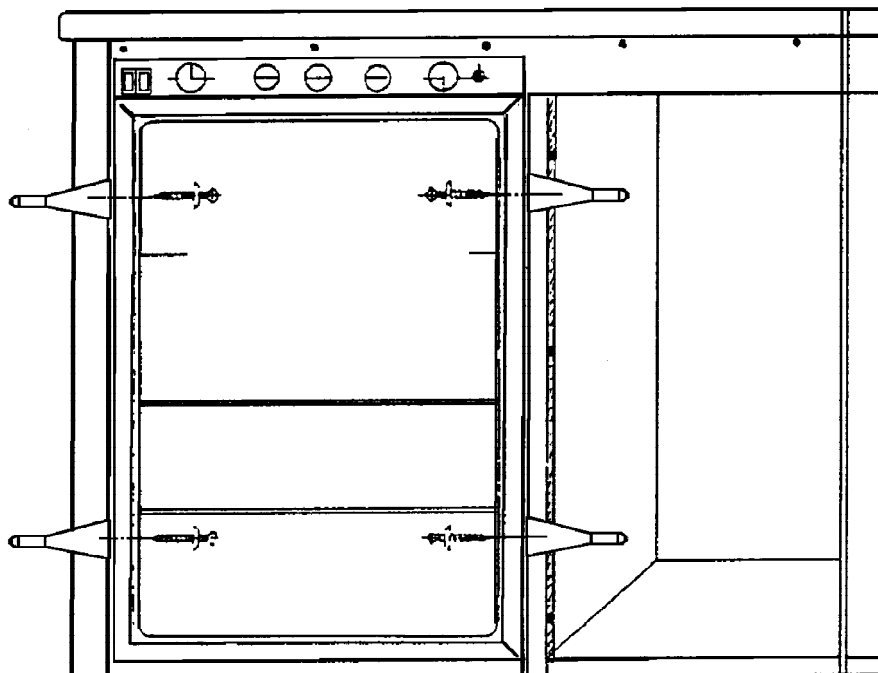
The Factory is aware of claims where the furniture was scratched when dismantling the refrigerator.

During installation of the refrigerator by the vehicle manufacturer (OEM) a sharp edge is formed at the point where the fixation screw is protruding.

This sharp edge damages the furniture when the refrigerator is moved out.

In order to avoid this scatching of the furniture it is **absolutely necessary** to move in four sheet metal pieces, e. g. spatulas, between the refrigerator side walls and the adjacent furniture walls, as shown in above sketch.
