Dishwasher/ Nuernberg Factory DGN

DIVA Dishwasher

→ Error code indication: **i10** and possibly also **iF0** or **i30**.

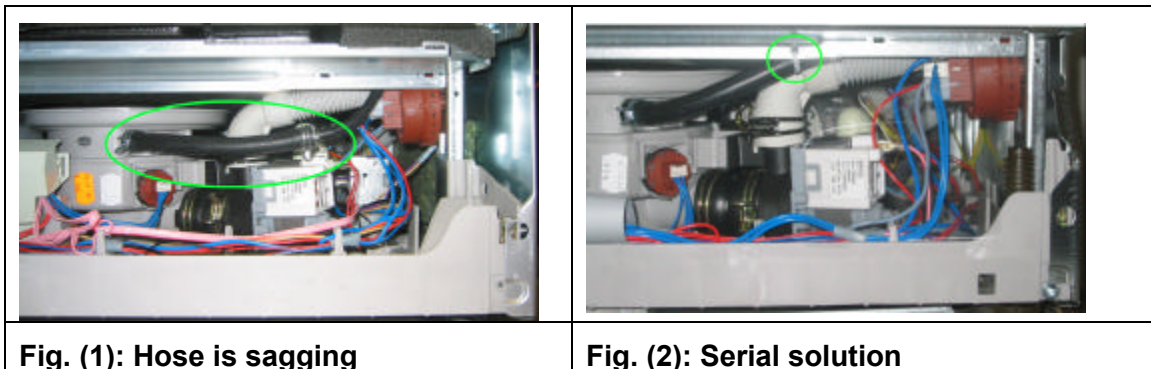
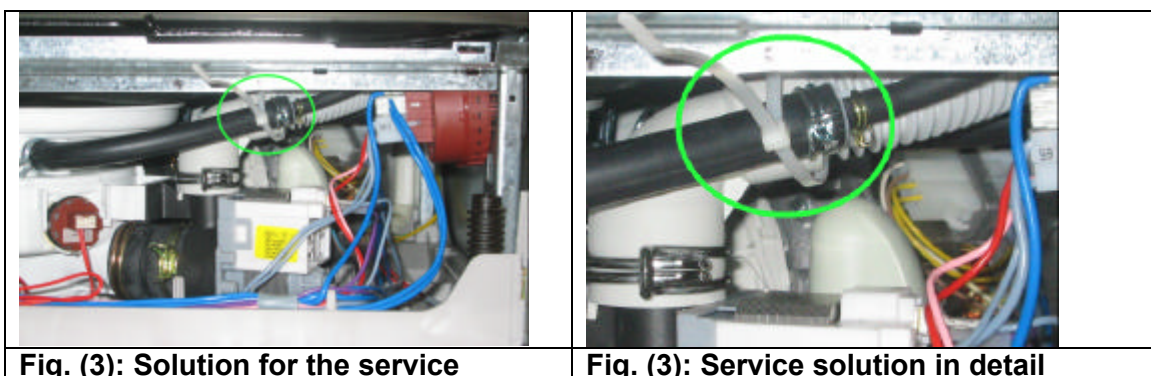
If the connecting hose does not ascend from the drain pan in the direction of the pressure control device, but runs horizontally or slightly sags ("forming of a water pocket"), this may lead to the error codes mentioned above.

The following figures show the problematic installation (1) (sagging) as well as a serial solution (2) and the solution for the service (3).

During production, the hose is fixed to a hole which is especially provided in the cross beam (2) using a cable tie.

→ Service solution: when working on the dishwasher, the connecting hose has to be fixed at the drain hose using a cable tie by way of precaution.
