Fitted cooker/oven with illuminated bar in the switch panel

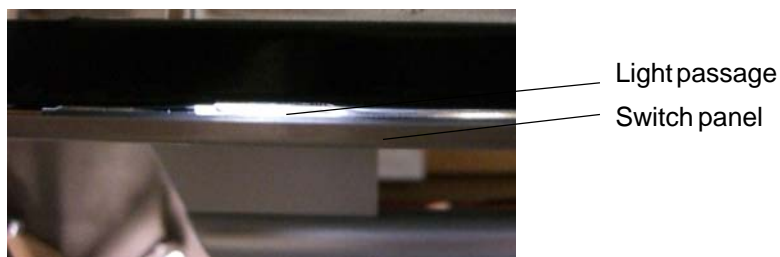
Problem: There have been complaints concerning the „gleaming“ of the illuminated bar upwards between the switch panel and the panel carrier.

Measures from the factory: Conversion to a screened illuminated bar which basically avoids the „gleaming“.
