TOO HIGH TEMPERATURES IN THE COOLER COMPARTMENT OF APPLIANCES WITH BATTERY EVAPORATOR

In the appliances with PNC starting with 925 034 xxx the following fault may occur:

cd001938

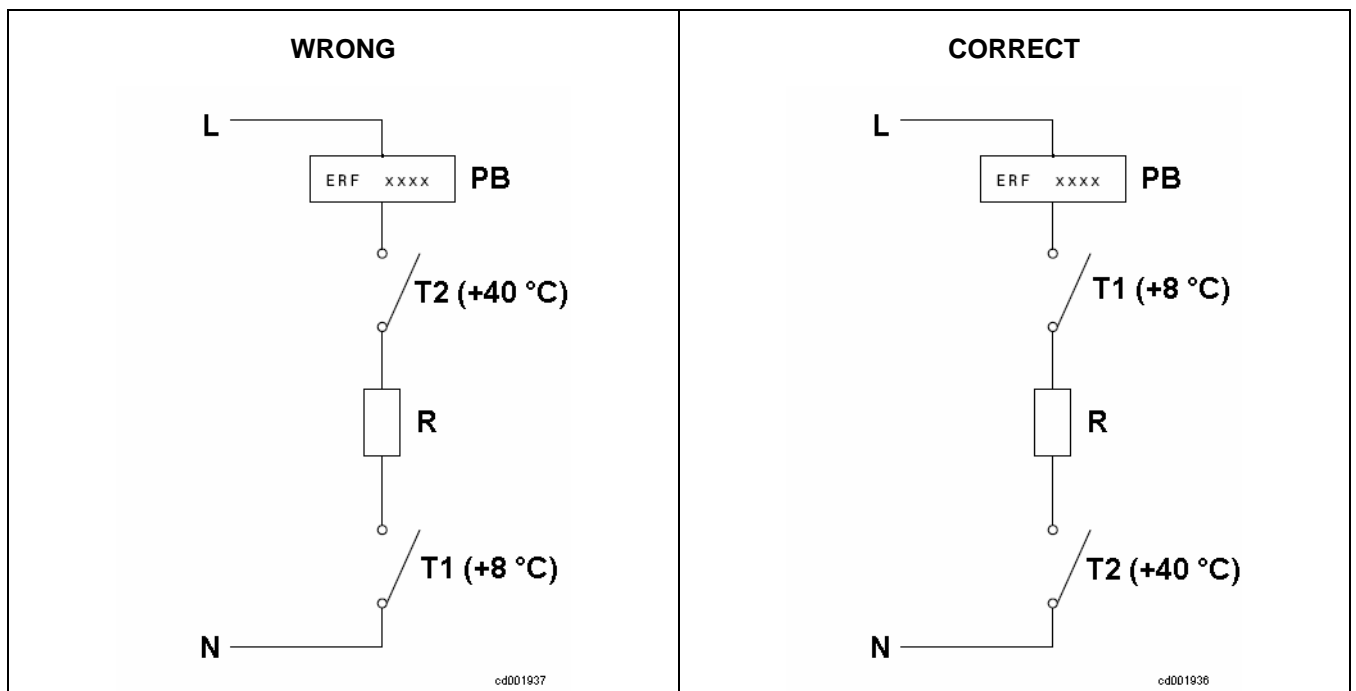
The thermal switches are correctly connected if the defrosting cut-out switch is directly connected to the power board, while they are wrongly connected if the thermal switch directly connected to the power board is the safety cut-out switch.

Please find below the wrong and the correct connection diagrams:

- L** = line
- N** = neutral
- PB** = power board
- R** = defrosting heater
- T1 (+8 °C)** = defrosting cut-out switch
- T2 (+40 °C)** = safety cut-out switch

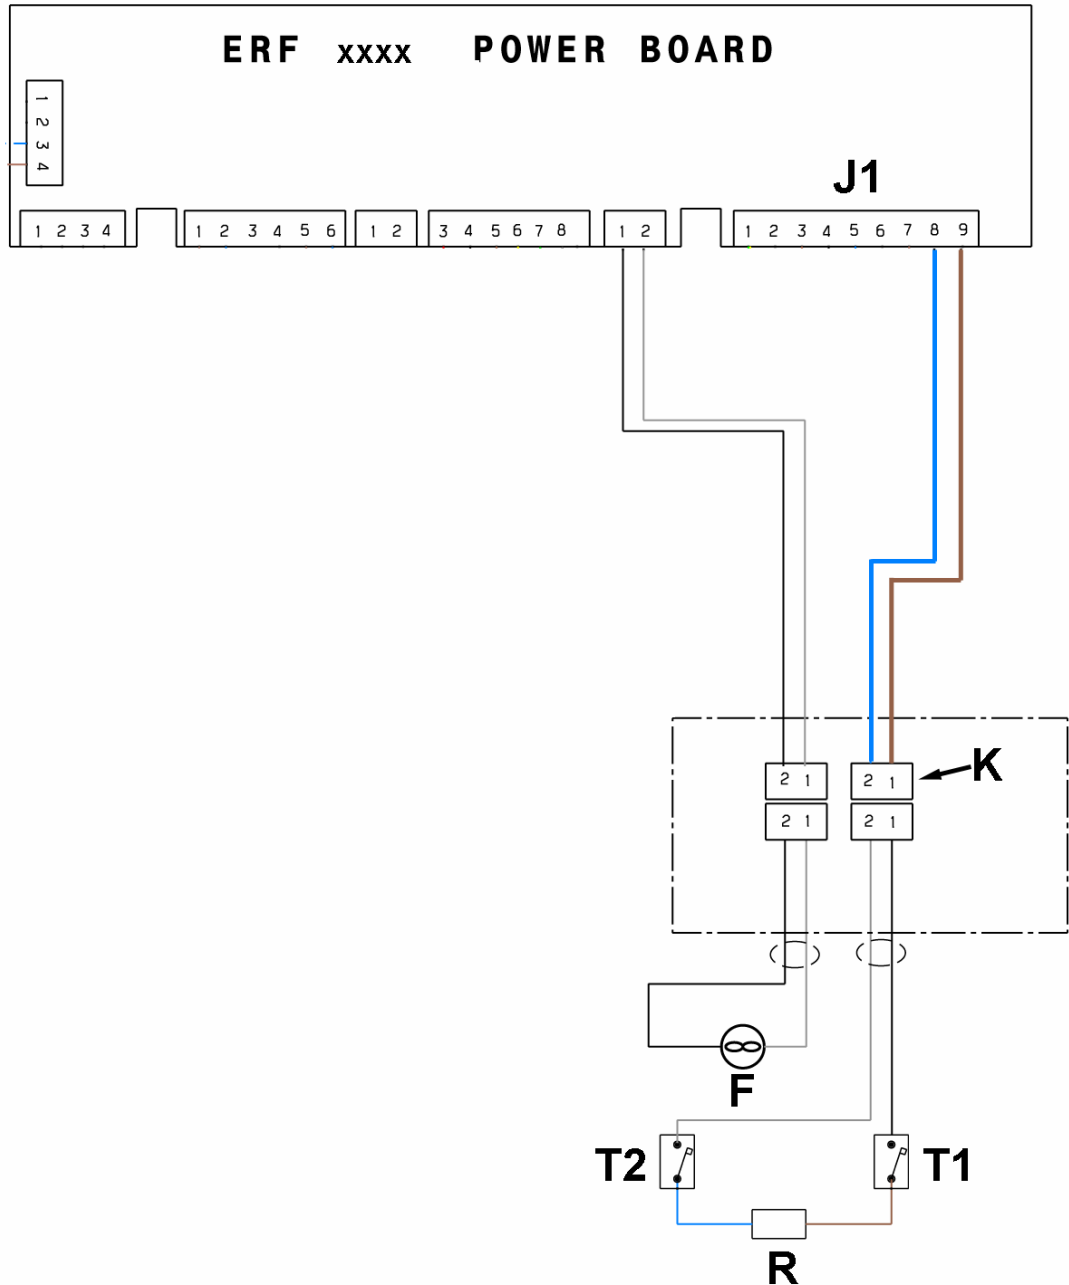
- K** = connector for connection of the thermal switches
- F** = fan
- R** = defrosting heater
- T1** = defrosting cut-out switch (+8 °C)
- T2** = safety cut-out switch (+40 °C)

To solve the problem of the wrong wiring of the thermal switches, it is necessary to modify the electric wiring as follows:
